Client Name:	City of Kalamazoo
Project Name:	Residential Asbestos Survey
Project Number:	188BS23113
Project Site Address (Subject Property):	740 E Vine Street, Kalamazoo, MI 49001
Date of Site Visit:	2/16/23
Asbestos Inspection Performed by:	Andrew DeLodder (A48677)
Asbestos Inspector's Signature:	<i>Andrew DeLodder</i>
Areas Not Accessible:	All Areas Accessible
Number of Floors:	1 Floor
Asbestos Present (Yes/No/Other):	Yes

On the date indicated above, State of Michigan Asbestos Inspector, Andrew DeLodder (A48677) from Atlas Technical Consultants, conducted a pre-demolition asbestos and other regulated materials inspection of the subject unoccupied residential property.

ASBESTOS-CONTAINING MATERIAL SURVEY
VACANT COMMERCIAL PROPERTY
740 E. VINE STREET
KALAMAZOO, MI 49001

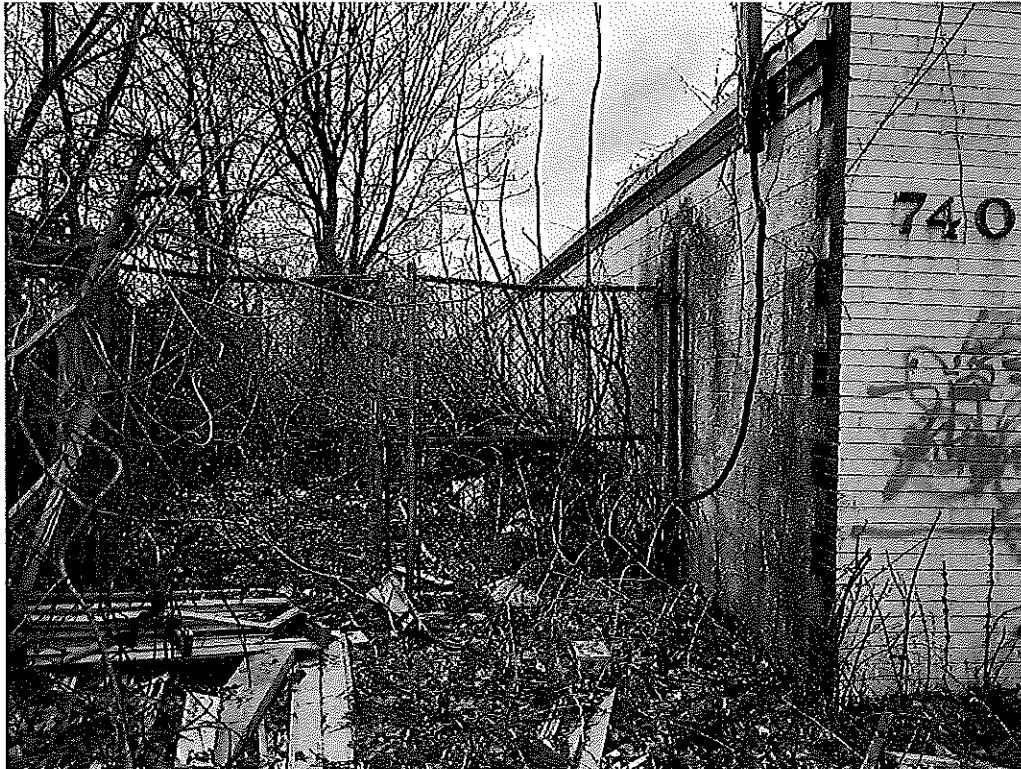
View of the left side of the building (EA-2)

3-EC-A,B,C	Exterior Caulk- Gray, around window void	EA-2	PLM 4% Chrysotile
4-EC-A,B,C	Exterior Caulk- White, around metal door frame	EA-4	PLM 5% Chrysotile
5-WG-A,B,C	Window Glaze- Beige, on window interior	EA-1,2,3,4	PLM 3% Chrysotile
6-TPL-A,B,C	Textured Plaster- rough/popcorn mixture (material applied to small section of wall, appears to be a test spot)	FS-3 (NW corner wall by Bay Door)	ND
7-WBS-A,B,C	Wallboard System- Building interior walls	FS-1,2,3,4,5,6	ND
8-FRB-A,B,C	Fiberboard- Ceilings	FS-1,2,3,4,5,6	ND
9-FT- A,B,C	Floor Tile 12" Stick-on, Diamond pattern (Boxes of tile, not applied to floor)	FS-1	ND
10-FT-A,B,C	Floor Tile 12" Stick-on, Faux wood pattern (Boxes of tile, not applied to floor)	FS-1	ND
11-FT-A,B,C	Floor Tile 12" Stick-on, Black Marble pattern (Boxes of tile, not applied to floor)	FS-1	ND
12-FT-A,B,C	Floor Tile 12" Stick-on, Rectangle & Diamond pattern (Boxes of tile, not applied to floor)	FS-1	ND

An asbestos abatement company, licensed in the State of Michigan should remove the materials identified as asbestos containing in Table I in accordance with all applicable Local, State, and Federal Requirements prior to demolition.
