Client Name:	City of Kalamazoo
Project Name:	Residential Asbestos Survey
Project Number:	188BS23113
Project Site Address (Subject Property):	744 E Vine Street, Kalamazoo, MI 49001
Date of Site Visit:	2/16/23
Asbestos Inspection Performed by:	Andrew DeLodder (A48677)
Asbestos Inspector's Signature:	<i>Andrew DeLodder</i>
Areas Not Accessible:	All Areas Accessible
Number of Floors:	1 Floor with Basement
Asbestos Present (Yes/No/Other):	Yes

ASBESTOS-CONTAINING MATERIAL SURVEY  
VACANT COMMERCIAL PROPERTY  
744 E. VINE STREET  
KALAMAZOO, MI 49001

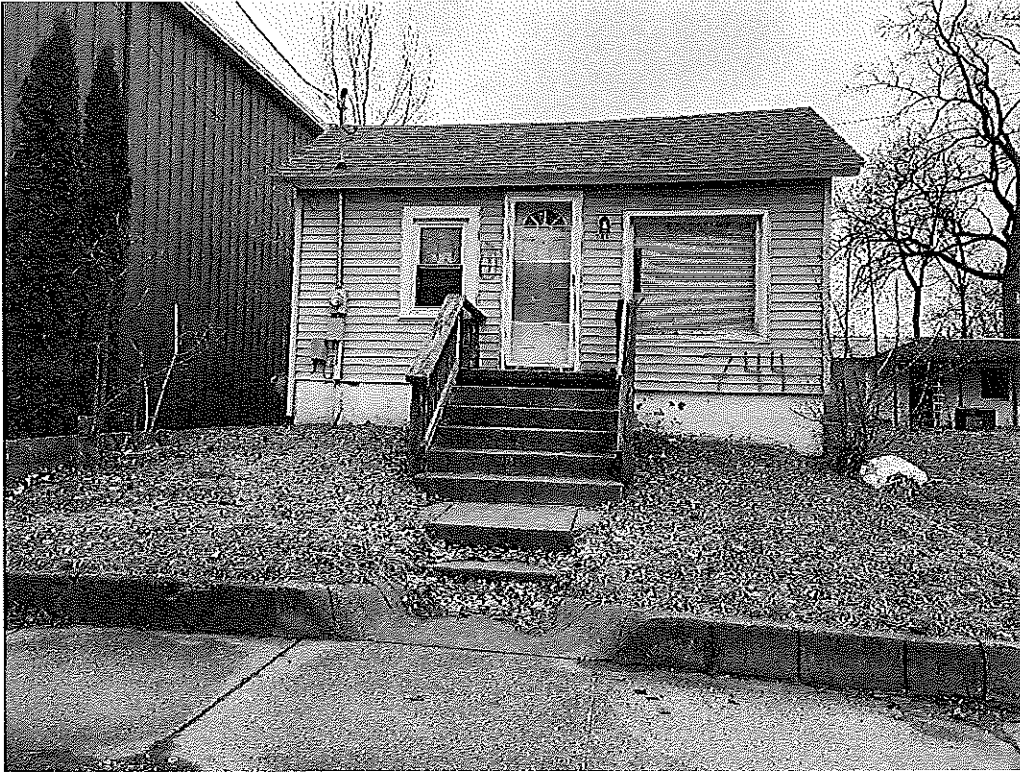
Street view of the house located at 740 E. Vine Street (EA-1) and roof (EA-5)

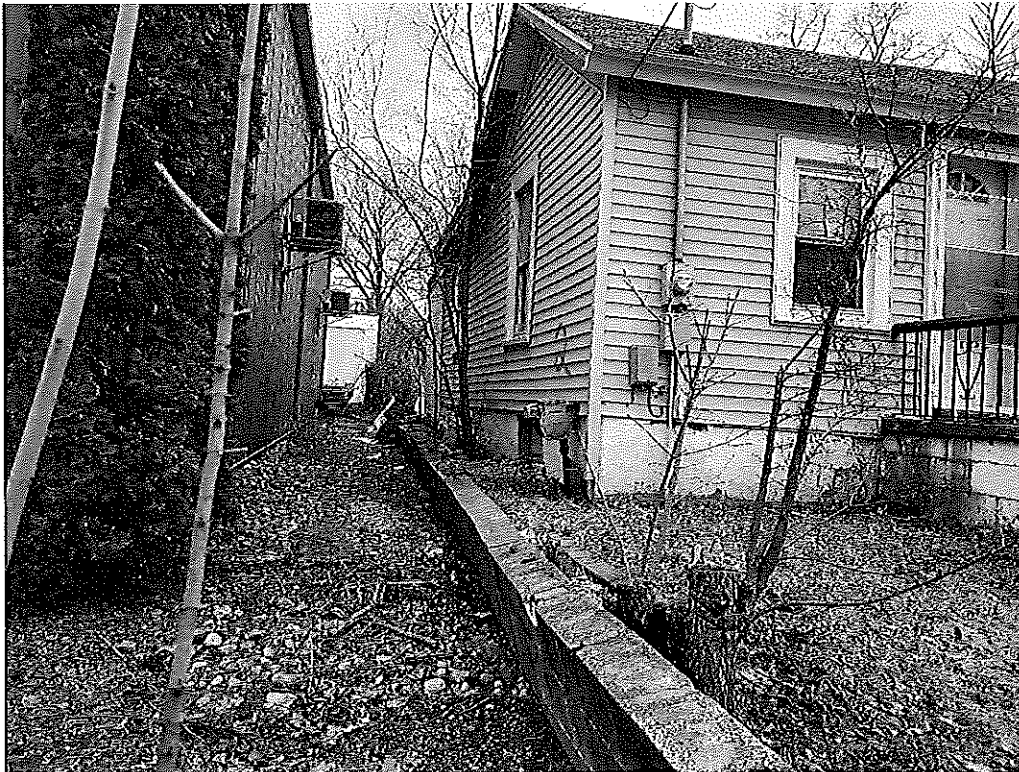
View of the left side of the house (EA-2)

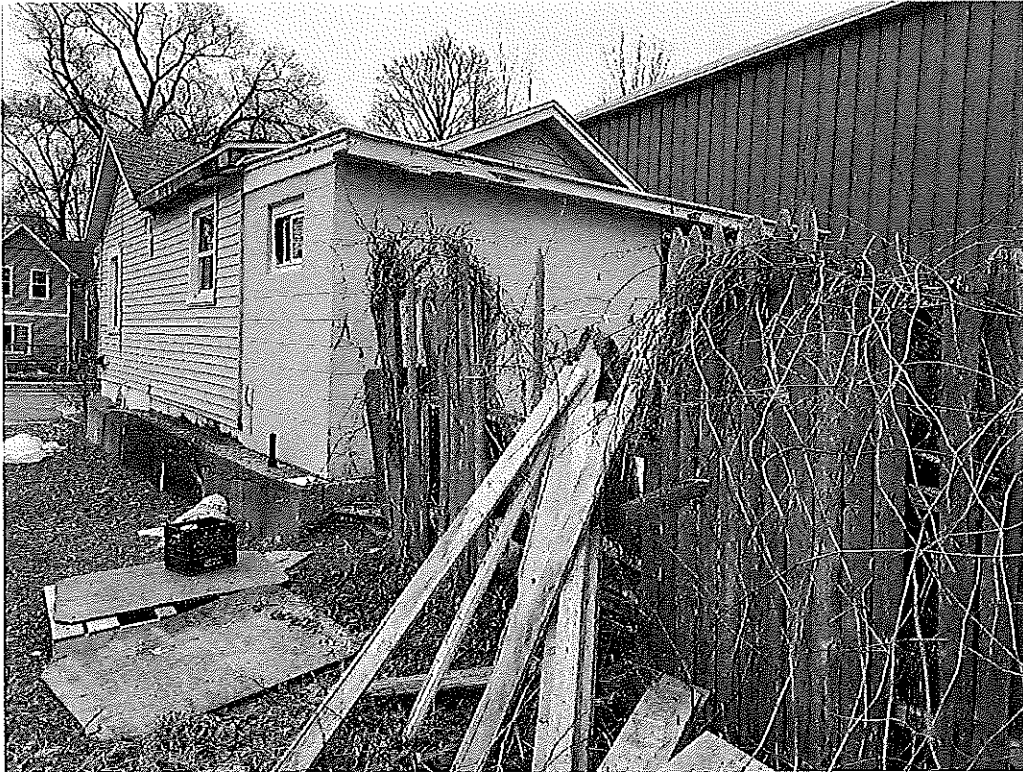
View of the rear of the house (EA-3)

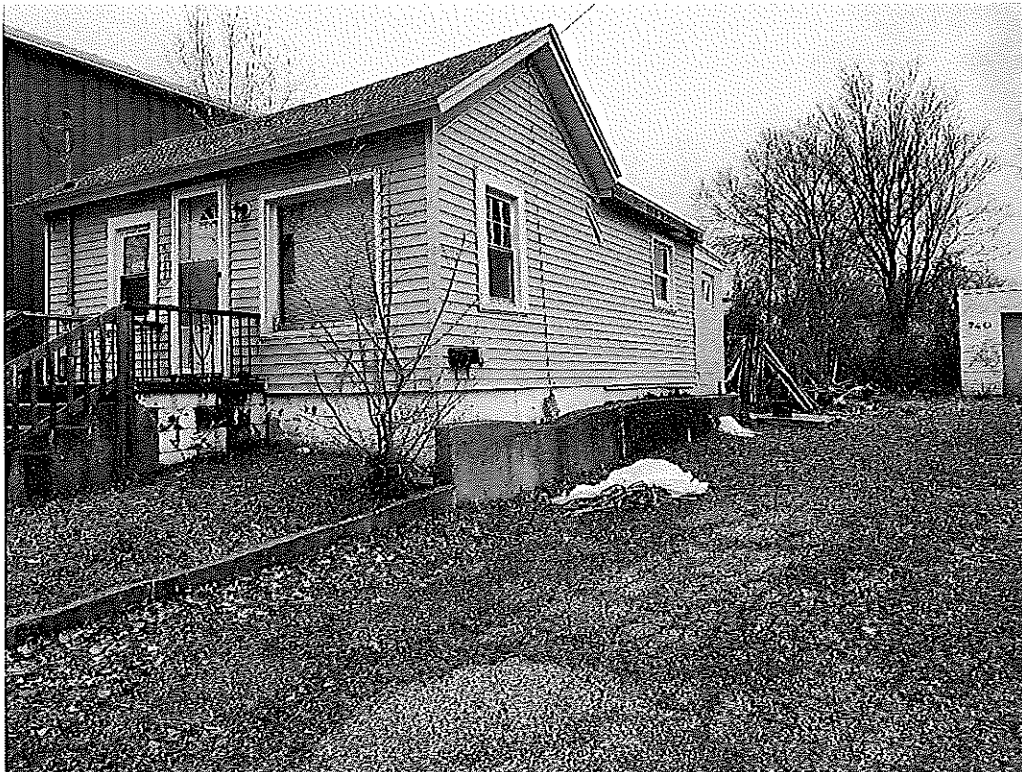
View of the right side of the house (EA-4)

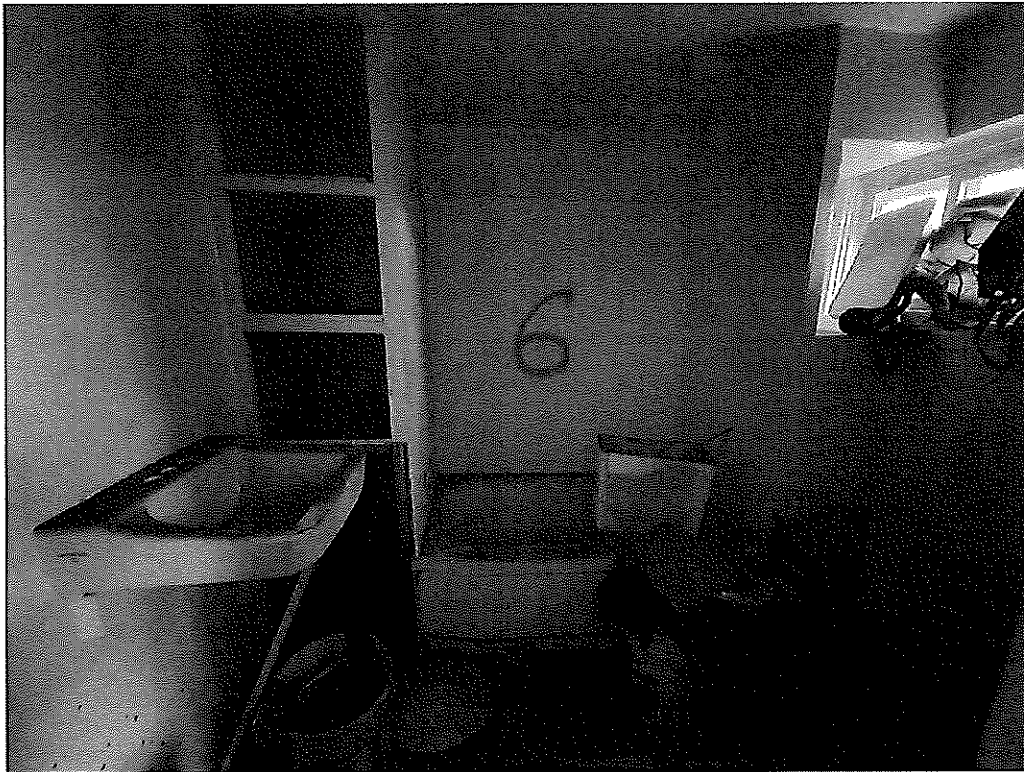
View of FS-6

23-FS-A,B,C	Floor Sheeting- Under Carpet	FS-4	ND
24-MLF-A,B,C	Multi-Layer Floor	FS-6	PLM 4% Chrysotile (FT Layer Only)
25-CA-A,B,C	Construction Adhesive- Under shower surround, Beige	FS-6	ND
26-BM-A,B,C	Brick Mortar- CMU Block	EA-2,3,4	ND
27-BM-A,B,C	Brick Mortar- Front Porch	EA-1	ND
28-BM-A,B,C	Brick Mortar- Exterior Foundation	EA-1,2,3,4	ND
29-CC-A,B,C	Concrete Chip- Exterior	EA-1,3,4	ND
30-CC-A,B,C	Concrete Chip- Back Room Slab	FS-5	ND
31-CC-A,B,C	Concrete Chip- Basement Floor	FS-8	ND
32-CC-A,B,C	Concrete Chip- Stairs to Basement	FS-7	ND
33-CC-A,B,C	Concrete Chip- Foundation Interior Skim Coat	FS-8	ND
34-IC-A,B,C	Interior Caulk- Around Toilet	FS-6	ND
35-PR-A,B,C	Packing Rope, brown around basement window frames & the seam between the foundation and the siding	EA-1.2.3.4	ND
36-DT-A,B,C	Duct Tape- Tape over HVAC seams with canvas material	FS-8	ND

An asbestos abatement company, licensed in the State of Michigan should remove the materials identified as asbestos containing in Table I in accordance with all applicable Local, State, and Federal Requirements prior to demolition.

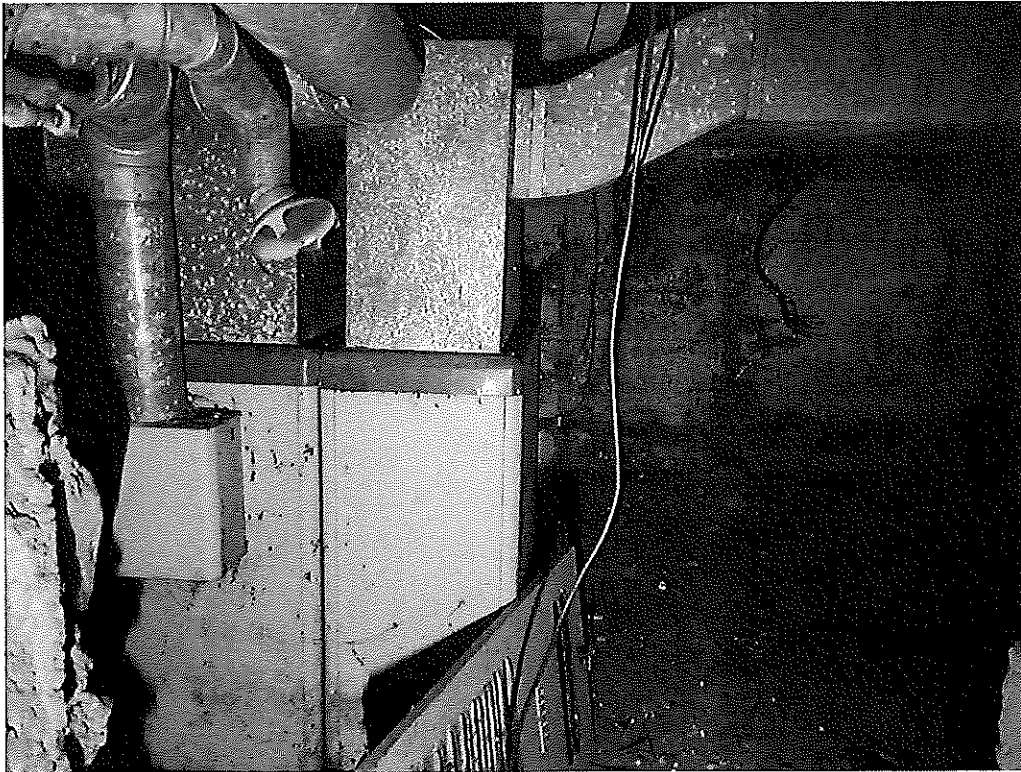
View of FS-8

17-HS-A,B,C	Heatshield- Fiberglass light fixture	FS- 1,2,3,4,5,6,7	ND
18-MB-A,B,C	Millboard- Above furnace and surrounding area	FS-8	PLM 60% Chrysotile
19-PI-A,B,C	Pipe Insulation- Wool-felt paper insulation, directly above furnace	FS-8	PLM 25% Chrysotile
20-DW-A,B,C	Duct Wrap- on ducts (Mainly on bottom of vents)	FS-8	PLM 80% Chrysotile
21-FS-A,B,C	Floor Sheeting- Under carpet	FS-2	ND
22-MLF-A,B,C	Multi-Layer Floor	FS-3	ND
