| Project Name: | Commercial Building Asbestos Survey |
| Project Site Address (Subject Property): | 328 E Stockbridge, Kalamazoo, MI 49001 |
| Date of Site Visit: | January 11, 2023 |

On the date indicated above, State of Michigan Asbestos Inspector, Andrew DeLodder (A48677) from Atlas Technical Consultants, conducted a pre-demolition asbestos and other regulated materials inspection of the subject unoccupied commercial property.

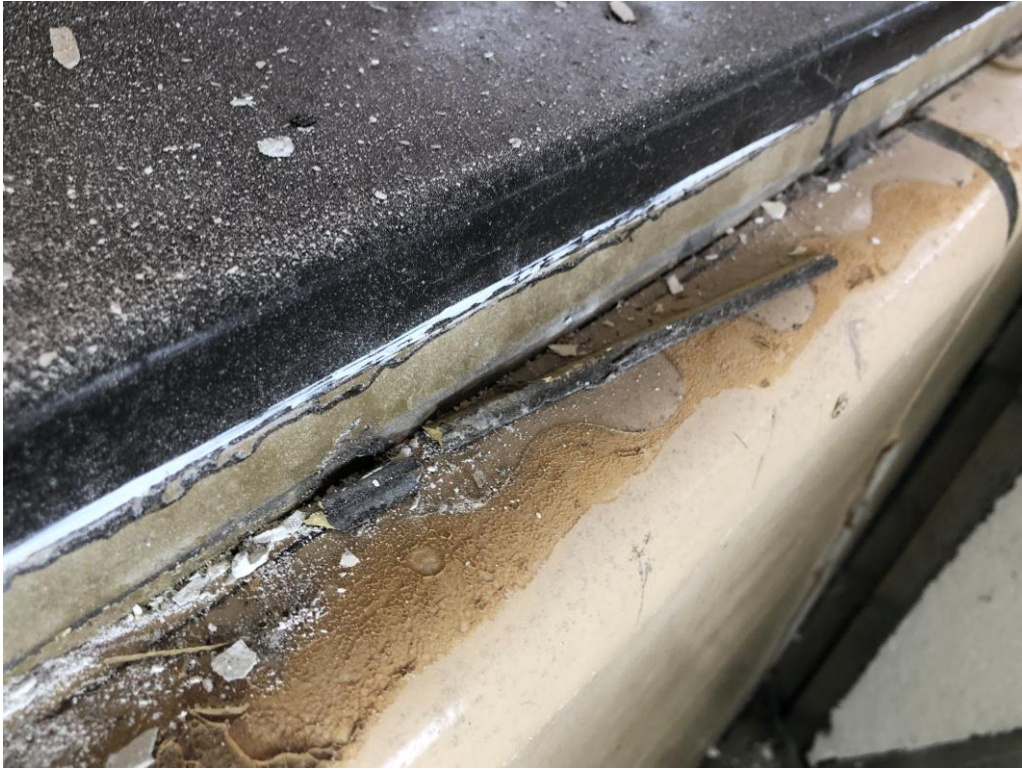
View of HA-12

| ID# | MATERIAL | LOCATION | QUANTITY | RESULT | NESHAP CATEGORY |
|---|--|---|---|---|---|
| 12-IC-A,B,C | Interior Caulk- Beige, Brittle, on Glazed Brick | FS- 1,2, 15 | 120 SF | PLM 3% Chrysotile | Cat II |

| HA/ID# | MATERIAL | LOCATION | RESULT |
|---|---|---|---|
| 12-IC-A,B,C | Interior Caulk- Beige, Brittle, on Glazed Brick | FS- 1,2, 15 | PLM 3% Chrysotile |

An asbestos abatement company, licensed in the State of Michigan should remove the materials identified as asbestos containing in Table I in accordance with all applicable Local, State, and Federal Requirements prior to demolition.

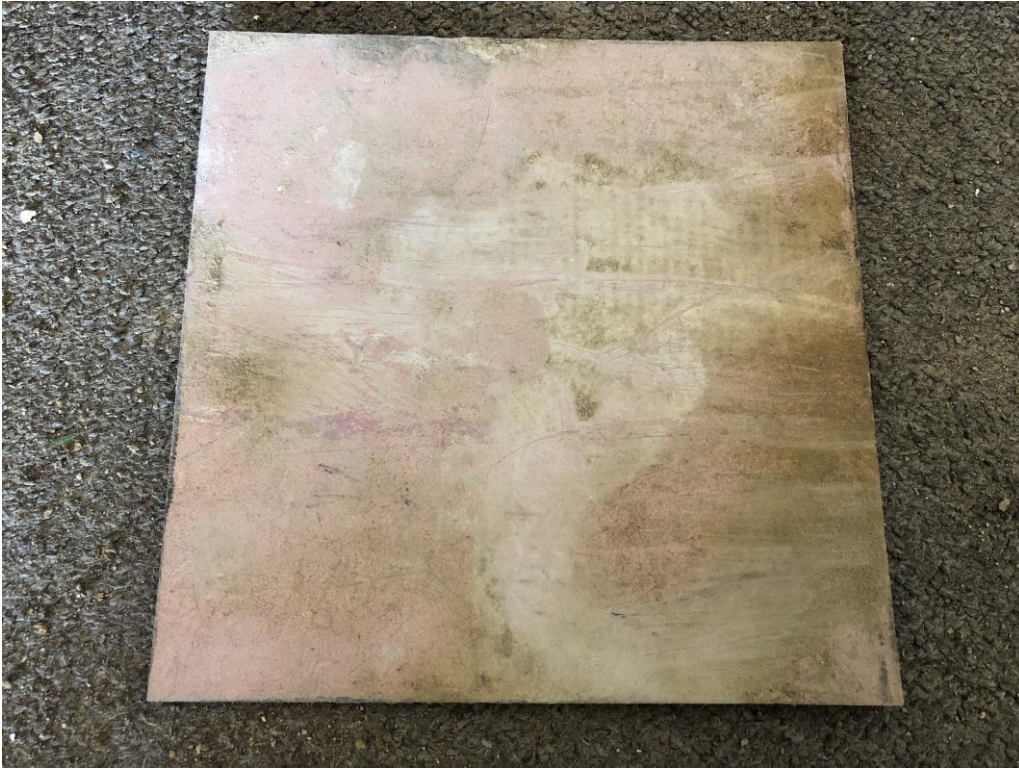
View of HA-36

| ID# | MATERIAL | LOCATION | QUANTITY | RESULT | NESHAP CATEGORY |
|---|--|---|---|---|---|
| 36-FT-A,B,C | Floor Tile- 9" Pink with Faint Gray Streaks, and Mastic | FS- 2 | 7,585 SF | PLM 4% Chrysotile (Floor Tile Only) | Cat I |

| 36-FT-A,B,C | Floor Tile- 9" Pink with Faint Gray Streaks, and Mastic | FS- 2 | PLM 4% Chrysotile (Floor Tile Only) |

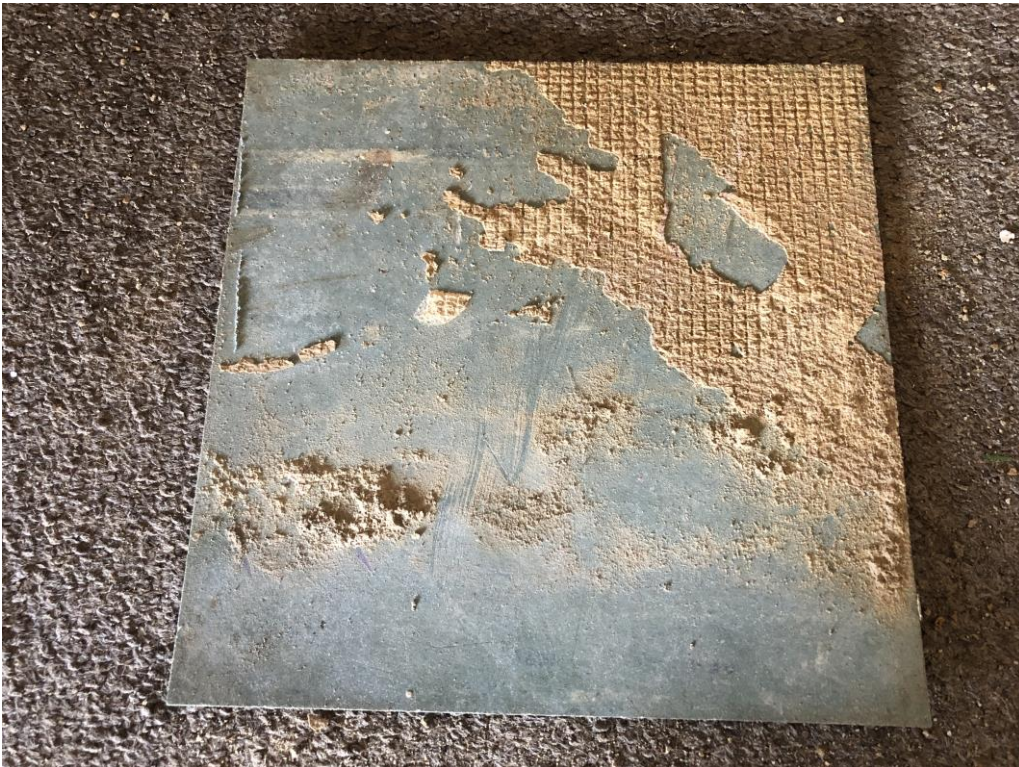
View of HA-37

| ID# | MATERIAL | LOCATION | QUANTITY | RESULT | NESHAP CATEGORY |
|---|--|---|---|---|---|
| 37-FT-A,B,C | Floor Tile- 9" Green with Faint Gray Streaks, and Mastic | FS- 2 | 7,585 SF | PLM 3% Chrysotile (Floor Tile Only) | Cat I |

| 37-FT-A,B,C | Floor Tile- 9" Green with Faint Gray Streaks, and Mastic | FS- 2 | PLM 3% Chrysotile (Floor Tile Only) |

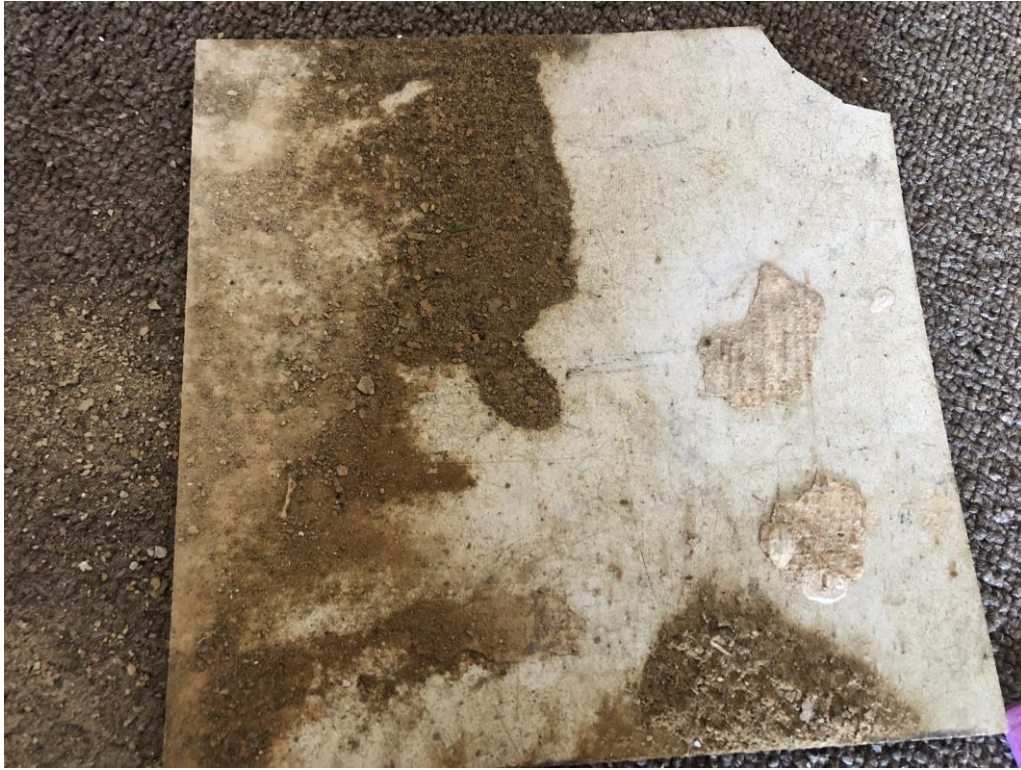
View of HA-38

| ID# | MATERIAL | LOCATION | QUANTITY | RESULT | NESHAP CATEGORY |
|---|--|---|---|---|---|
| 38-FT-A,B,C | Floor Tile- 9" Off-White with Faint Gray Streaks, and Mastic | FS- 2,6,7 | 8,035 SF | PLM 4% Chrysotile (Floor Tile Only) | Cat I |

| 38-FT-A,B,C | Floor Tile- 9" Off-White with Faint Gray Streaks, and Mastic | FS- 2,6,7 | PLM 4% Chrysotile (Floor Tile Only) |

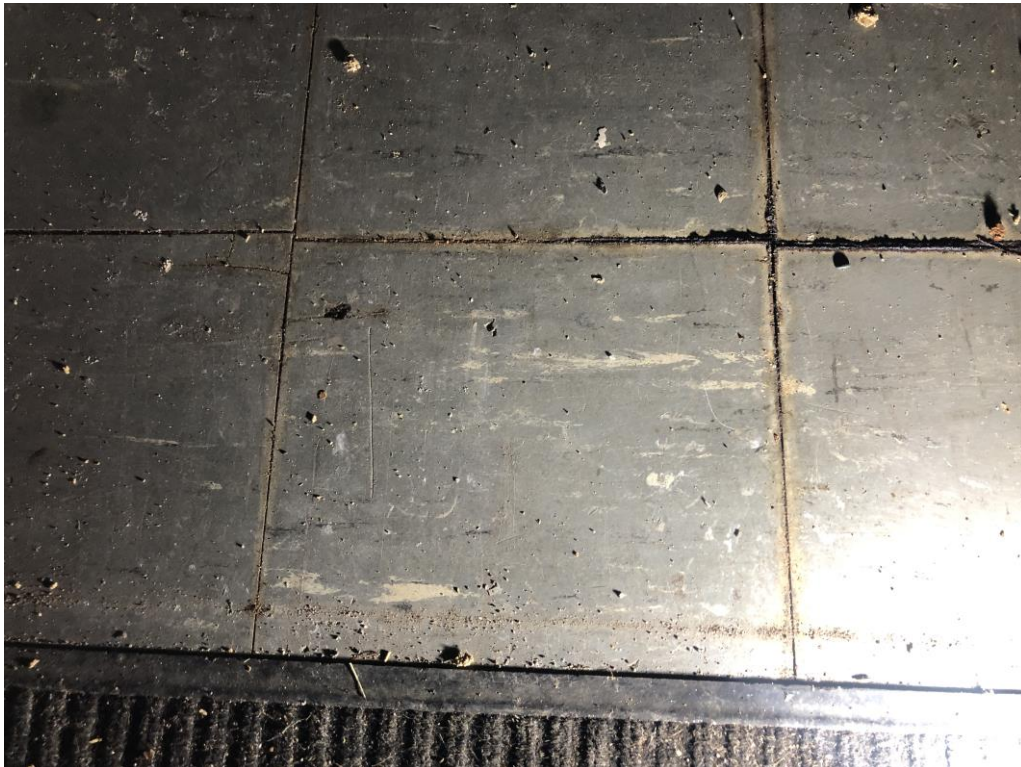
View of HA-39

| ID# | MATERIAL | LOCATION | QUANTITY | RESULT | NESHAP CATEGORY |
|---|--|---|---|---|---|
| 39-FT-A,B,C | Floor Tile- 9" Gray with Faint Gray Streaks, and Mastic | FS- 5 | 20 SF | PLM 3% Chrysotile (Floor Tile Only) | Cat I |

| 39-FT-A,B,C | Floor Tile- 9" Gray with Faint Gray Streaks, and Mastic | FS- 5 | PLM 3% Chrysotile (Floor Tile Only) |

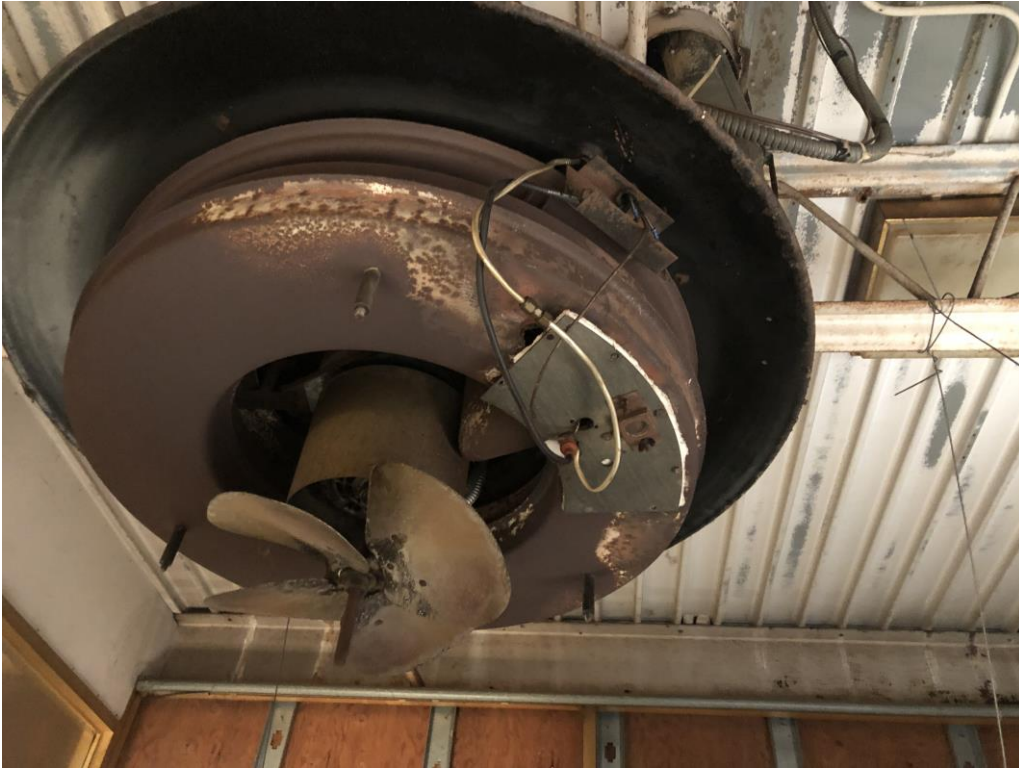
View of HA-48

| ID# | MATERIAL | LOCATION | QUANTITY | RESULT | NESHAP CATEGORY |
|---|--|---|---|---|---|
| 48-HS-A,B,C | Heat Shield- White, Between Panels on HVAC Fan | FS-1 | 2 SF | PLM 80% Chrysotile | RACM |

| 48-HS-A,B,C | Heat Shield- White, Between Panels on HVAC Fan | FS-1 | PLM 80% Chrysotile |

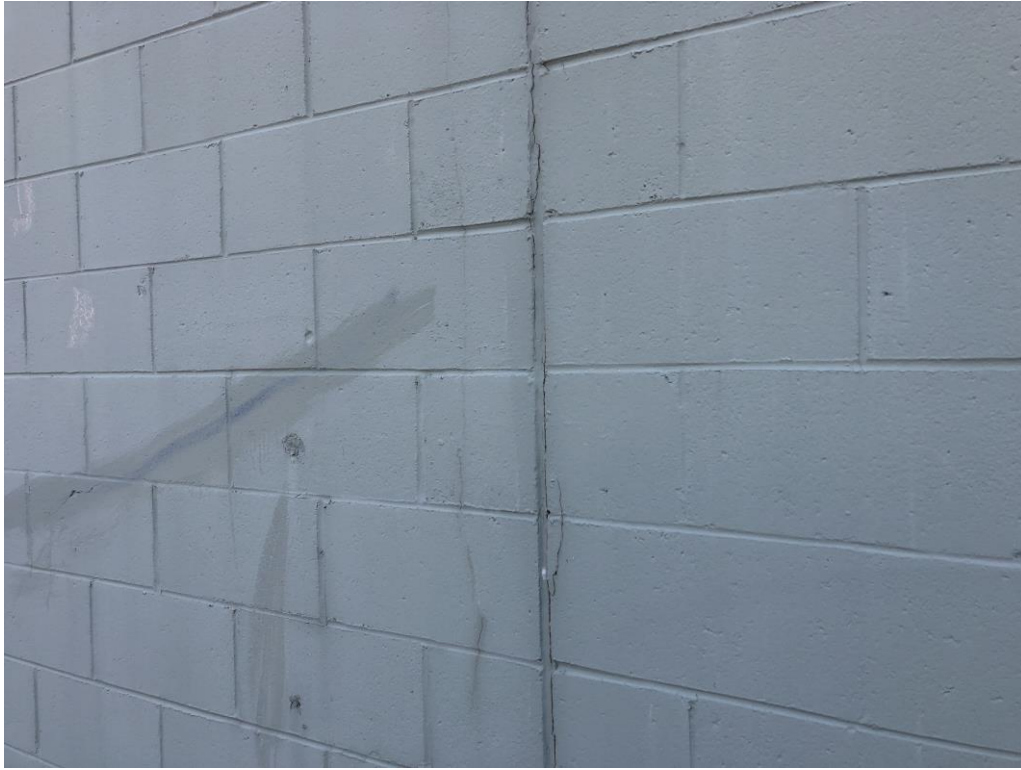
View of HA-50

| ID# | MATERIAL | LOCATION | QUANTITY | RESULT | NESHAP CATEGORY |
|---|--|---|---|---|---|
| 50-EJ-A,B,C | Expansion Joint- CMU Block | EA- 1,3 | 300 LF | PLM 3% Chrysotile | RACM |

| 50-EJ-A,B,C | Expansion Joint- CMU Block | EA- 1,3 | PLM 3% Chrysotile |

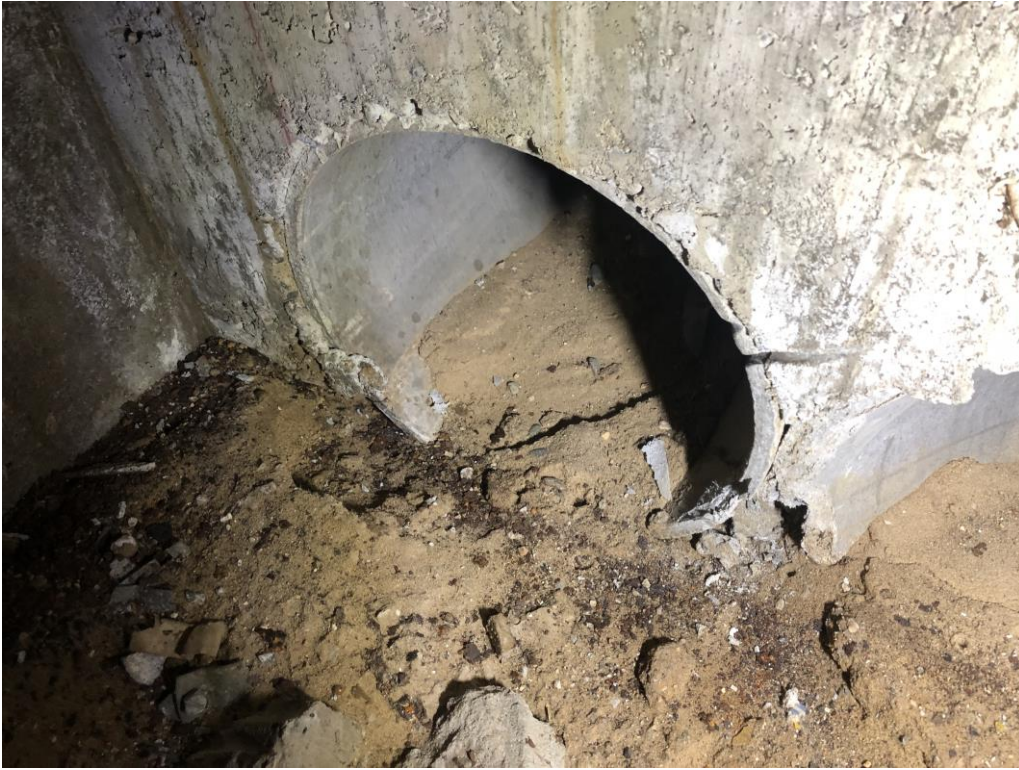
View of HA-56

| ID# | MATERIAL | LOCATION | QUANTITY | RESULT | NESHAP CATEGORY |
|---|--|---|---|---|---|
| 56-TS-A,B,C | Transite Pipe, Under Foundation | FS-5 | UNQ | PLM 60% Chrysotile | Cat II |

| 56-TS-A,B,C | Transite Pipe, Under Foundation | FS-5 | PLM 60% Chrysotile |

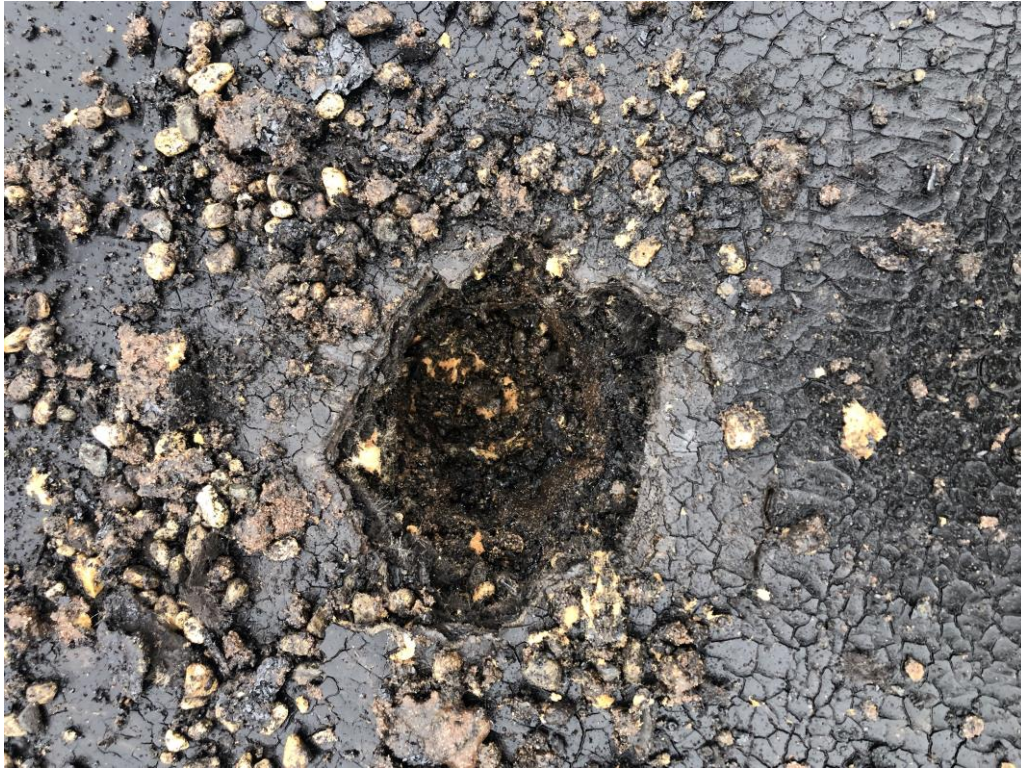
View of HA-58

| ID# | MATERIAL | LOCATION | QUANTITY | RESULT | NESHAP CATEGORY |
|---|--|---|---|---|---|
| 58-RC-A,B,C,D,E,F | Roofing Core | EA-5 (Lower & Upper Roof) | 19,300 SF | PLM 5% Chrysotile | Cat I |

| 58-RC-A,B,C,D,E,F | Roofing Core | EA-5 (Lower & Upper Roof) | PLM 5% Chrysotile |

Since demolition activities do not include sanding, grinding, cutting, or abrading, Category I asbestos-containing roofing materials not in poor condition and not friable are not considered RACM, and are allowed to remain in place during demolition.

If the asbestos-containing roofing material is not in poor condition and is not friable, it may be disposed of in a landfill which accepts ordinary demolition waste.

The asbestos-containing roofing material may not be ground up for recycling into other products.

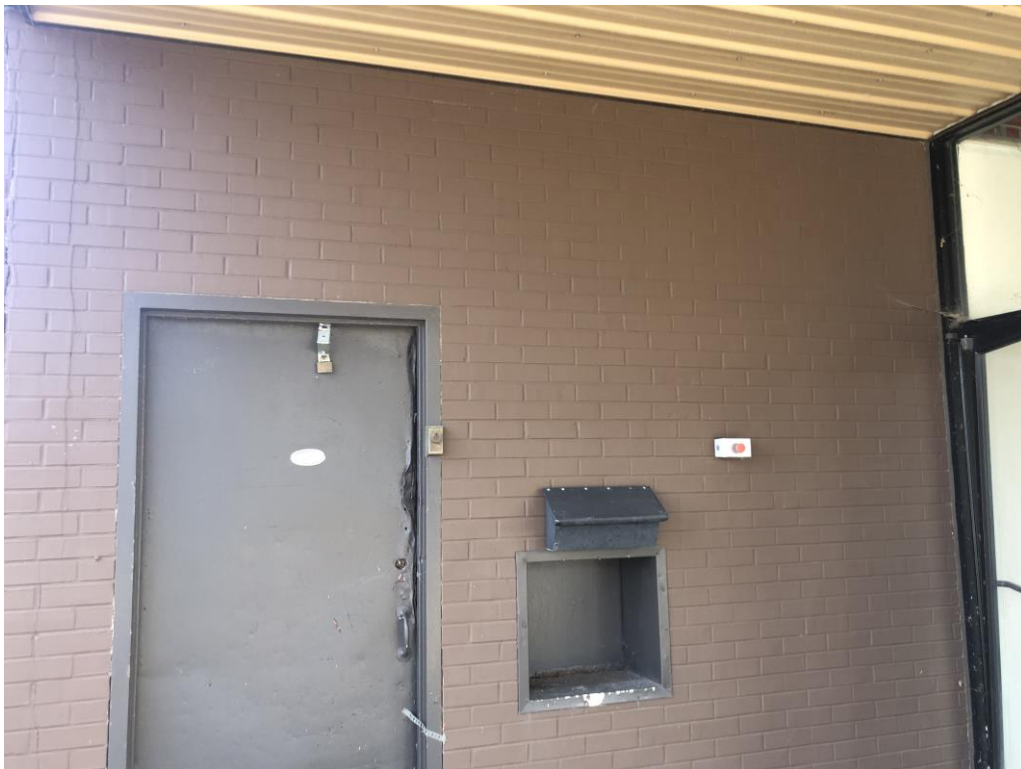
View of HA-59

| ID# | MATERIAL | LOCATION | QUANTITY | RESULT | NESHAP CATEGORY |
|---|--|---|---|---|---|
| 59-FD-A,B,C | Fire Door- Metal Door with White Interior Lining | EA-1 | 1 DOOR | PLM 10% Chrysotile | RACM |

| 59-FD-A,B,C | Fire Door- Metal Door with White Interior Lining | EA-1 | PLM 10% Chrysotile |
