Atlas Technical Consultants

Client Name:	City of Kalamazoo
Project Name:	Residential Garage Asbestos Survey
Project Number:	188BS22300
Project Site Address (Subject Property):	1117 Cobb Avenue, Kalamazoo, MI 49007
Parcel Number:	06-16-204-007
Date of Site Visit:	4/29/2022
Asbestos Inspection Performed by:	Andrew DeLodder (A48677)
Asbestos Inspector's Signature:	<i>Andrew DeLodder</i>
Areas Not Accessible:	All areas accessible
Number of Floors:	one 2-story, approximately 490 square foot (SF), garage
Asbestos Present (Yes/No/Other):	Yes

On the date indicated above, State of Michigan Asbestos Inspector, Andrew DeLodder (A48677) from Atlas Technical Consultants, conducted a pre-demolition asbestos and other regulated materials inspection of the subject residential property.

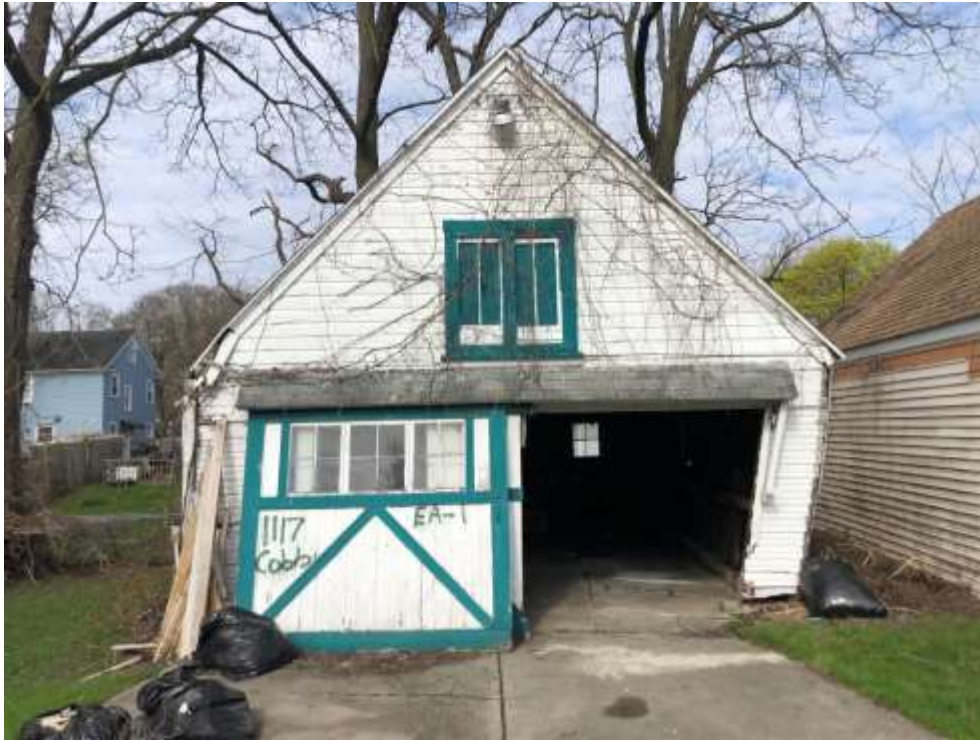
View of the garage located at 1117 Cobb Avenue (EA-1)

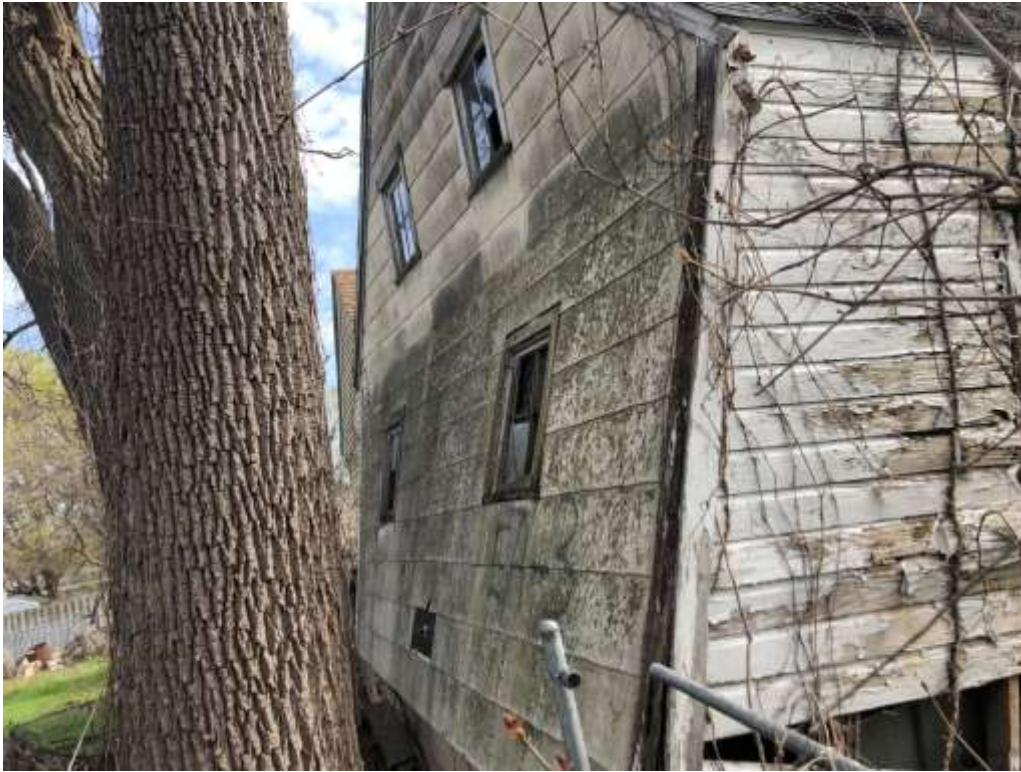
ID#	MATERIAL	LOCATION	QUANTITY	RESULT	NESHAP CATEGORY
3-WG-A,B,C	Window glaze, multi-pane on exterior and stack in attic (FS-2)	EA 1-4, FS-1,2	14 Windows	2% Chrysotile	Category II
4-TS-A,B,C	Transite siding	EA-3	330 SF	8% Chrysotile	Category II

View of the rear of the garage (EA-3)

An asbestos abatement company, licensed in the State of Michigan should remove the materials identified as asbestos containing in Table I in accordance with all applicable Local, State, and Federal Requirements prior to demolition.

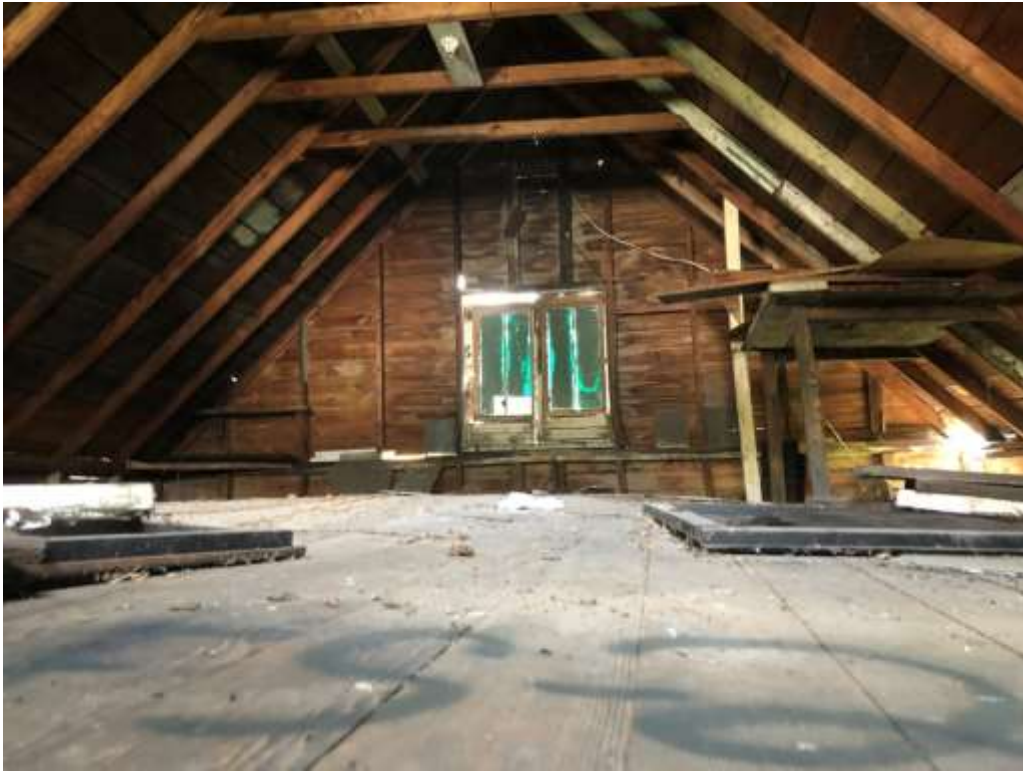
View of the garage attic (FS-2)
