Client Name:	City of Kalamazoo
Project Name:	Commercial Building Asbestos Survey
Project Number:	188BS23418
Project Site Address (Subject Property):	1011 Cobb Street, Kalamazoo, MI 49700
Date of Site Visit:	May 24, 2023
Asbestos Inspection Performed by:	Corey Pruitt (A57116)
Asbestos Inspector's Signature:

ASBESTOS-CONTAINING MATERIAL SURVEY  
VACANT RESIDENTIAL PROPERTY  
1011 COBB STREET  
KALAMAZOO, MI 49007

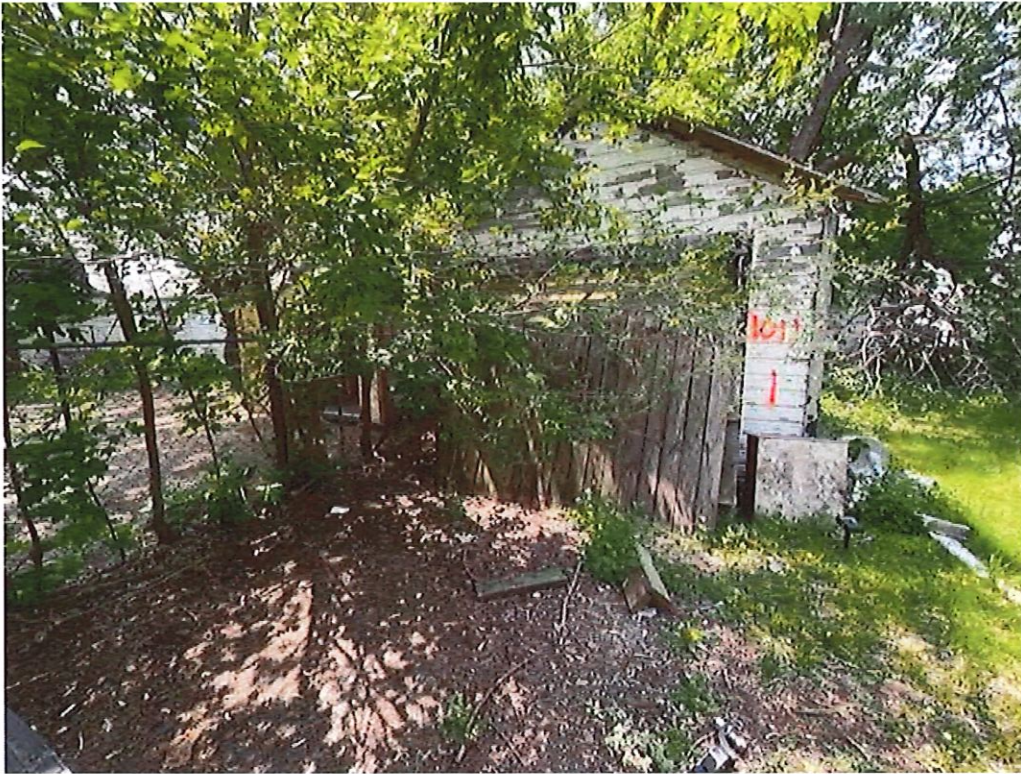
Street view of the house located at 1011 Cobb Street (EA-1) / (EA-5)

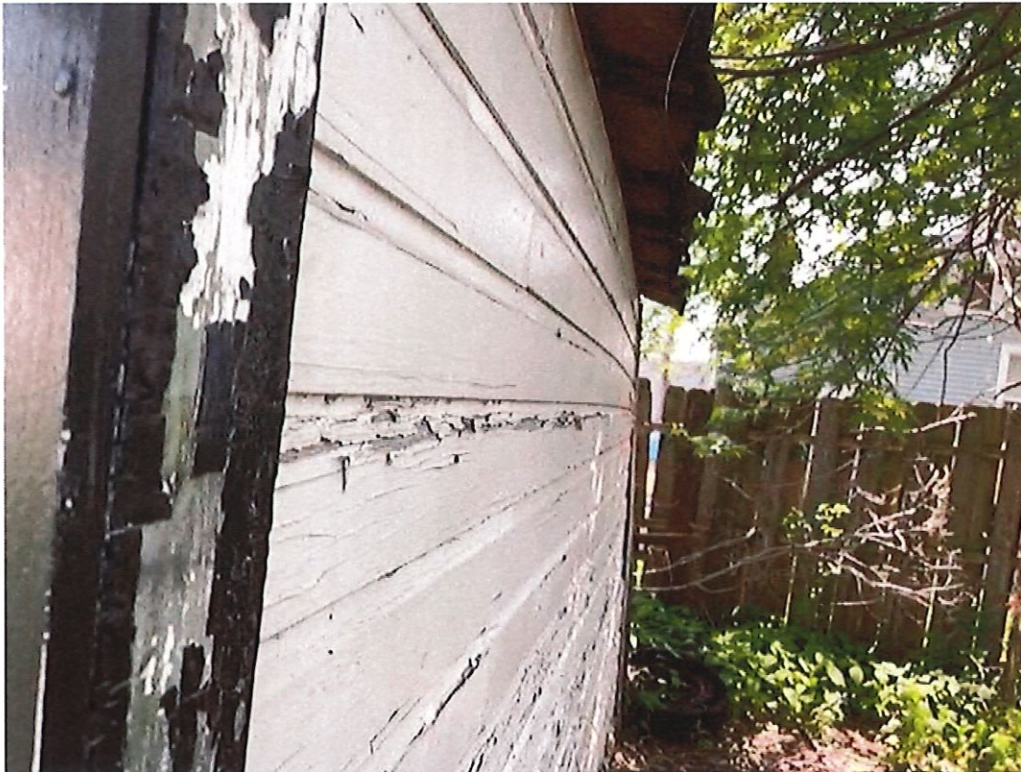
View of the left side of the house (EA-2)

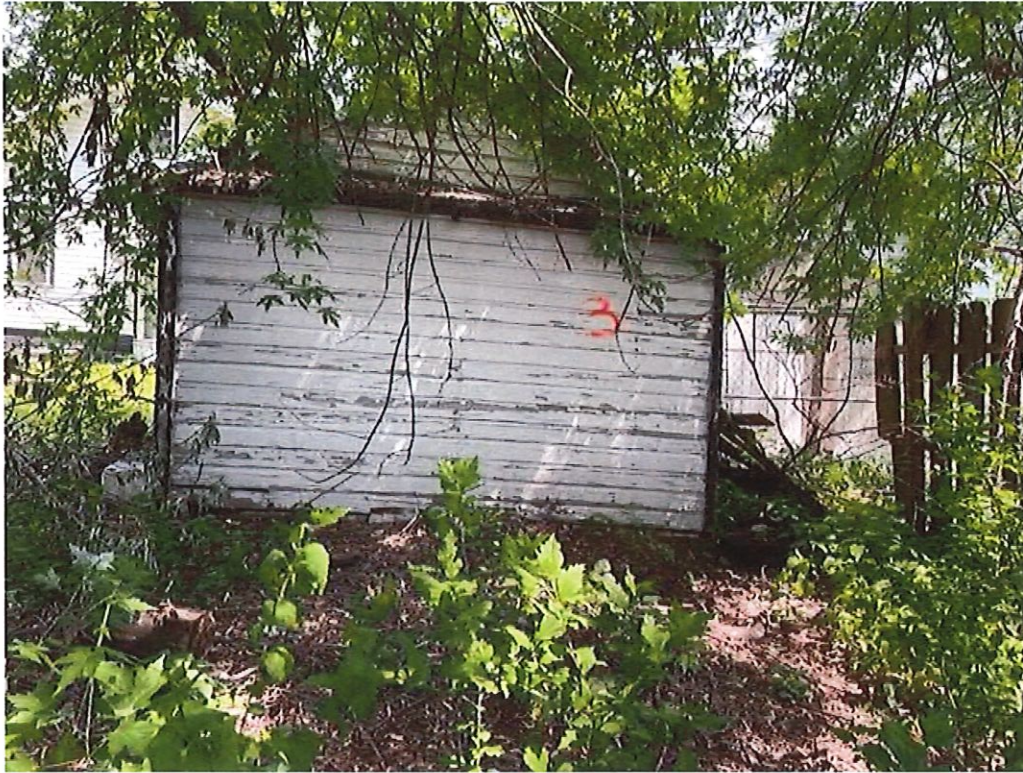
View of the rear of the house (EA-3)

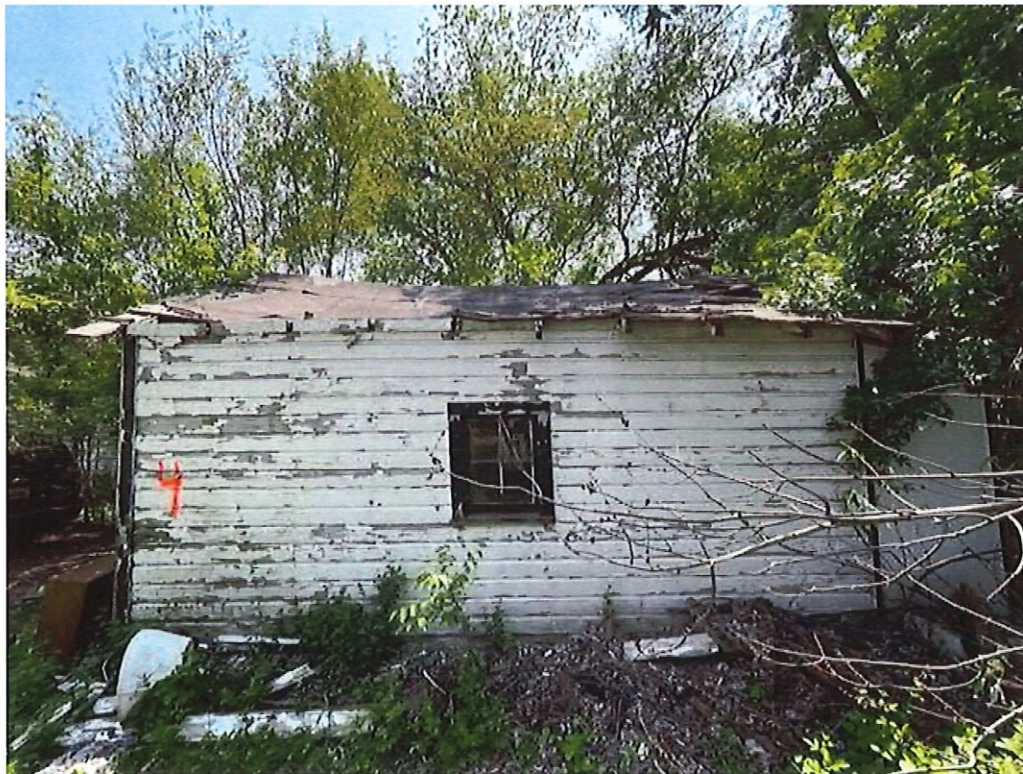
View of the right side of the house (EA-4)

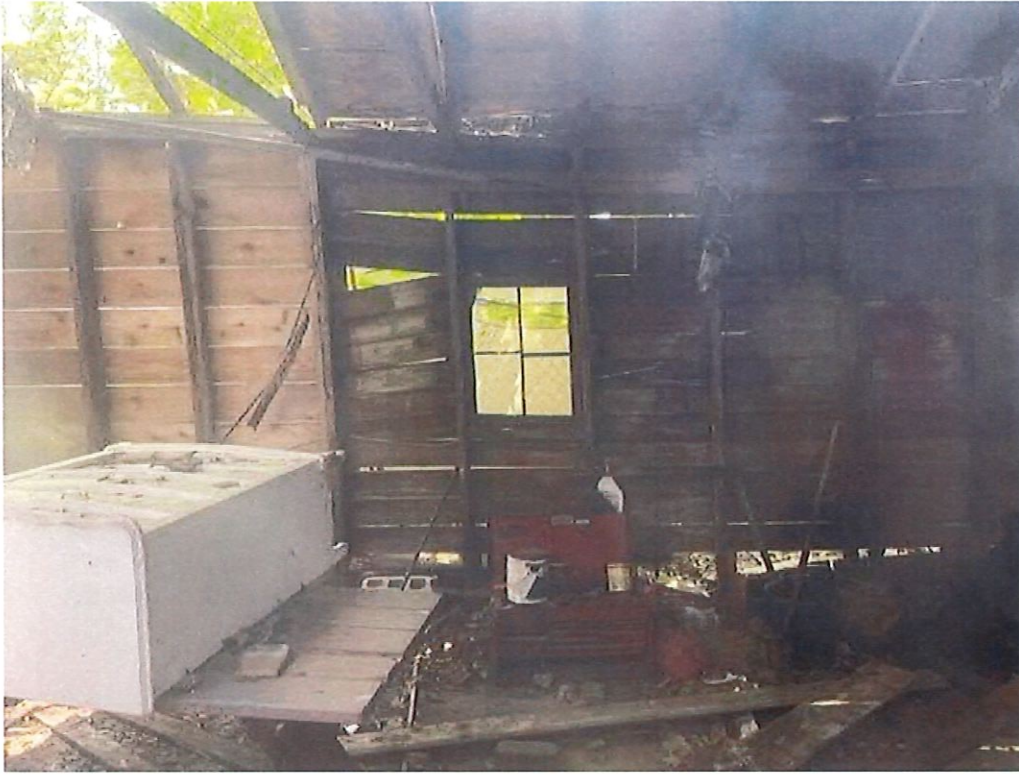
View of FS-1

Areas Not Accessible:	Interior of garage was inaccessible
Number of Floors:	Garage Only
Asbestos Present (Yes/No/Other):	No asbestos identified in areas surveyed, however asbestos may be present in inaccessible areas.
