Client Name:	City of Kalamazoo
Project Name:	Commercial Building Asbestos Survey
Project Number:	188BS23419
Project Site Address (Subject Property):	1423 N Edwards, Kalamazoo, MI 49700
Date of Site Visit:	May 24, 2023
Asbestos Inspection Performed by:	Corey Pruitt (A57116)
Asbestos Inspector's Signature:

On the date indicated above, State of Michigan Asbestos Inspector, Corey Pruitt (A57116) from Atlas Technical Consultants, conducted a pre-demolition asbestos and other regulated materials inspection of the subject unoccupied commercial property.

ASBESTOS-CONTAINING MATERIAL SURVEY
VACANT RESIDENTIAL PROPERTY
1423 N EDWARDS ST.
KALAMAZOO, MI 49007

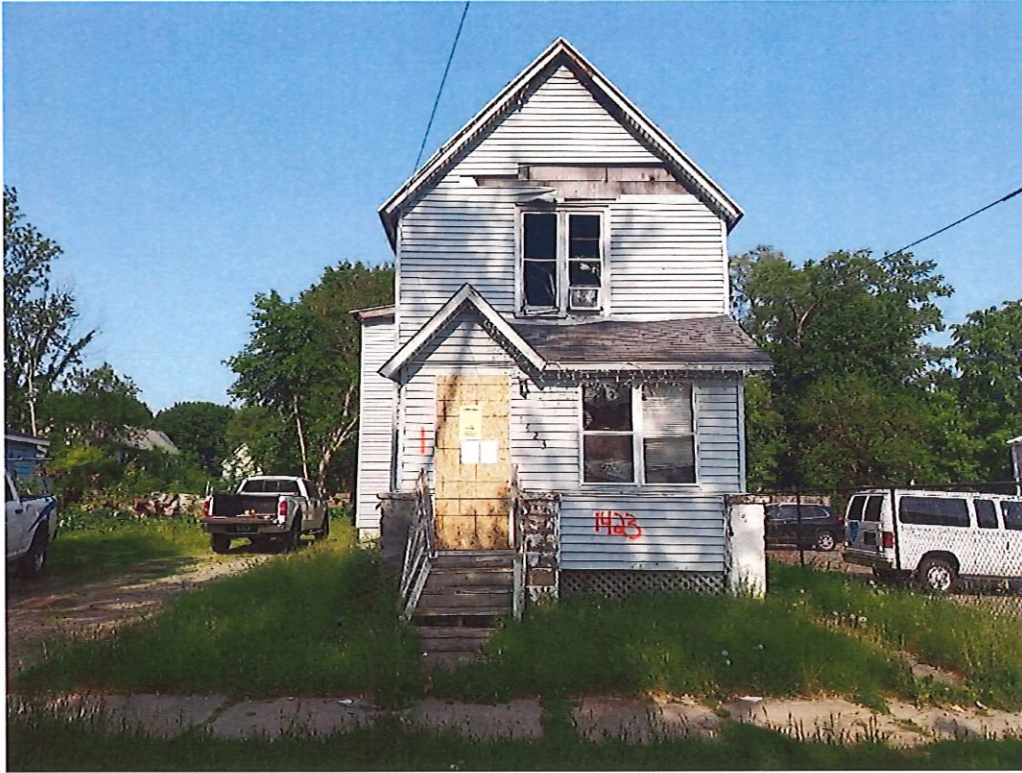
Street view of the house located at 1423 N Edwards (EA-1)/(EA-5)

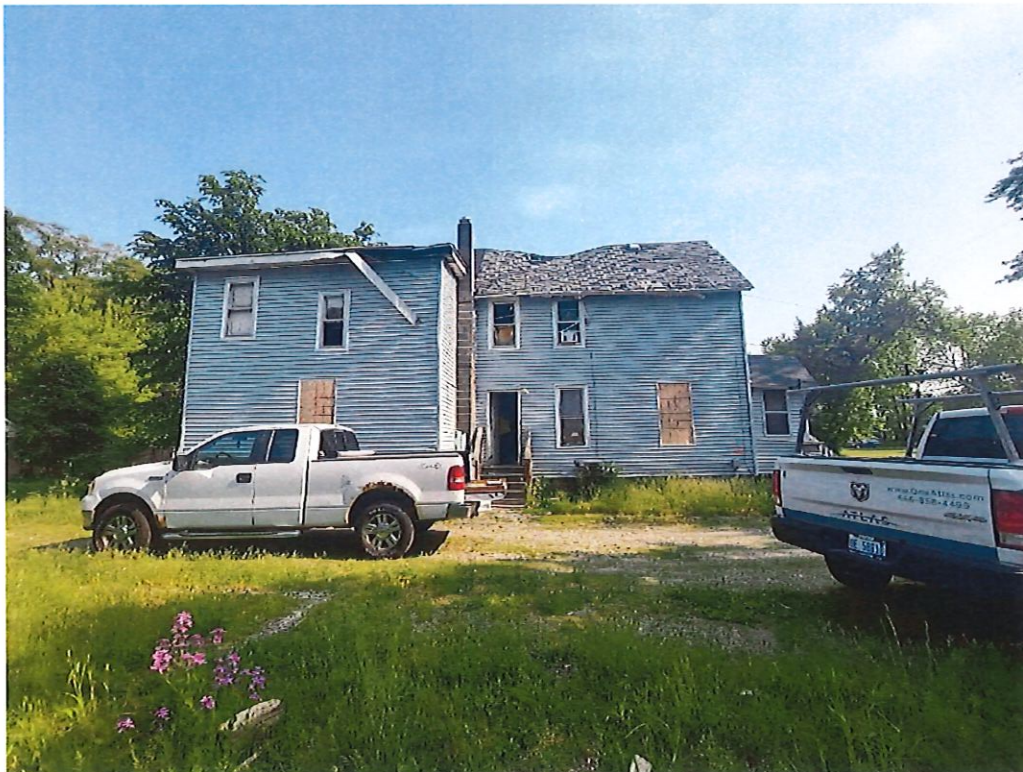
View of the left side of the house (EA-2)

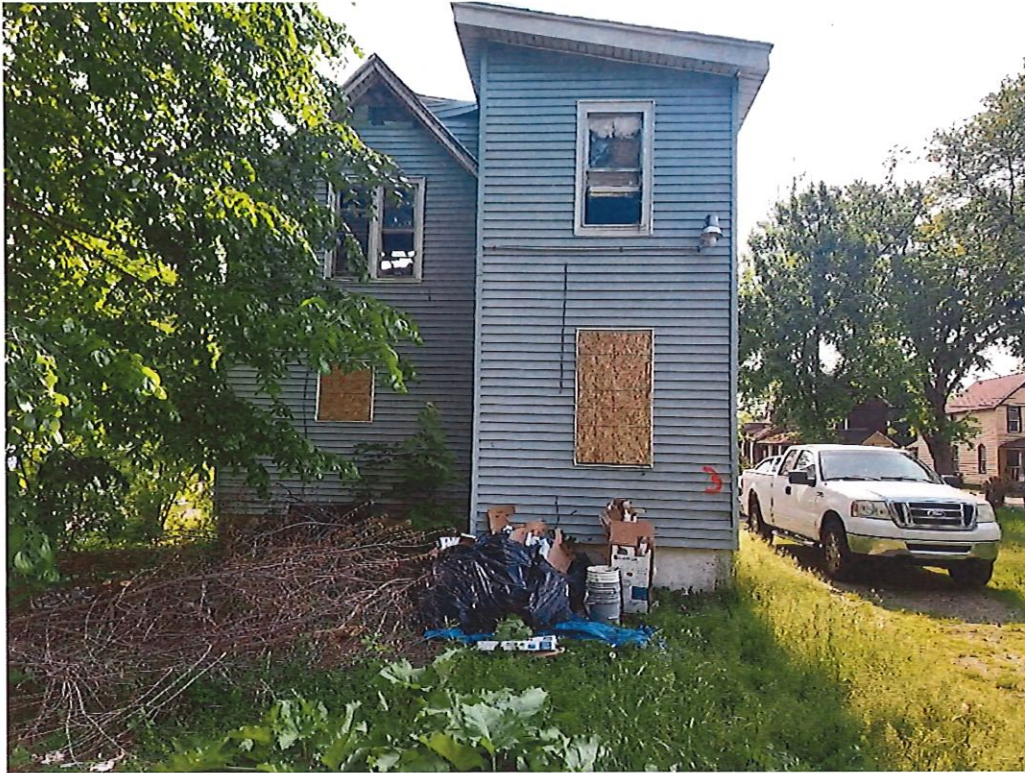
View of the rear of the house (EA-3)

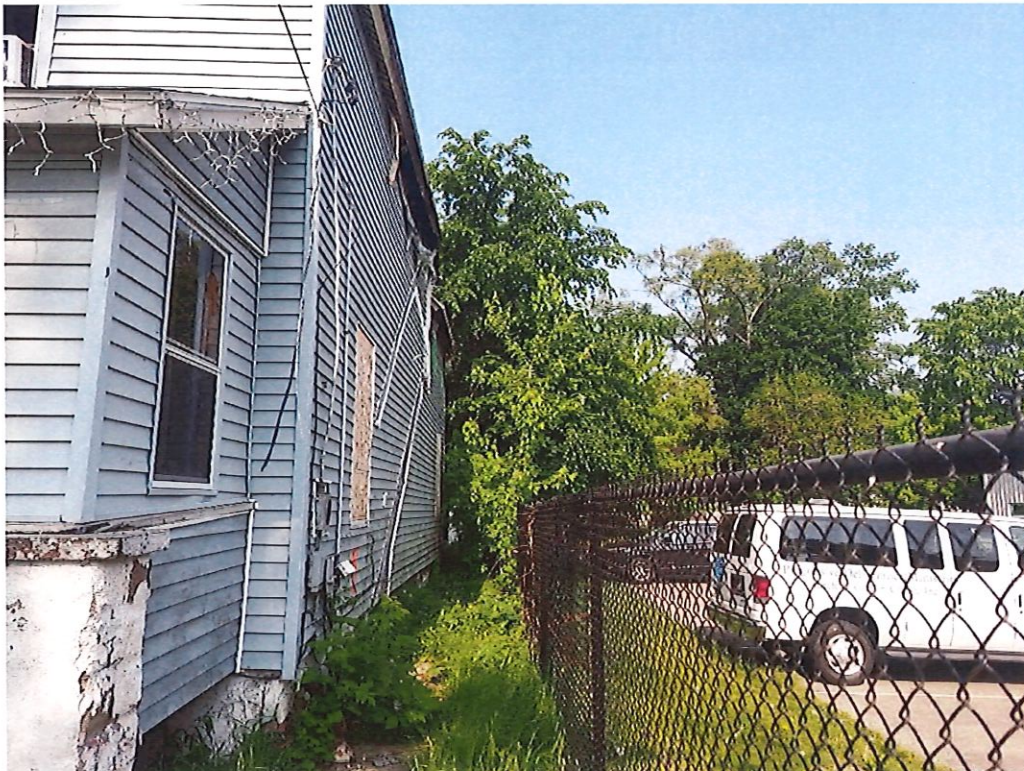
View of the right side of the house (EA-4)

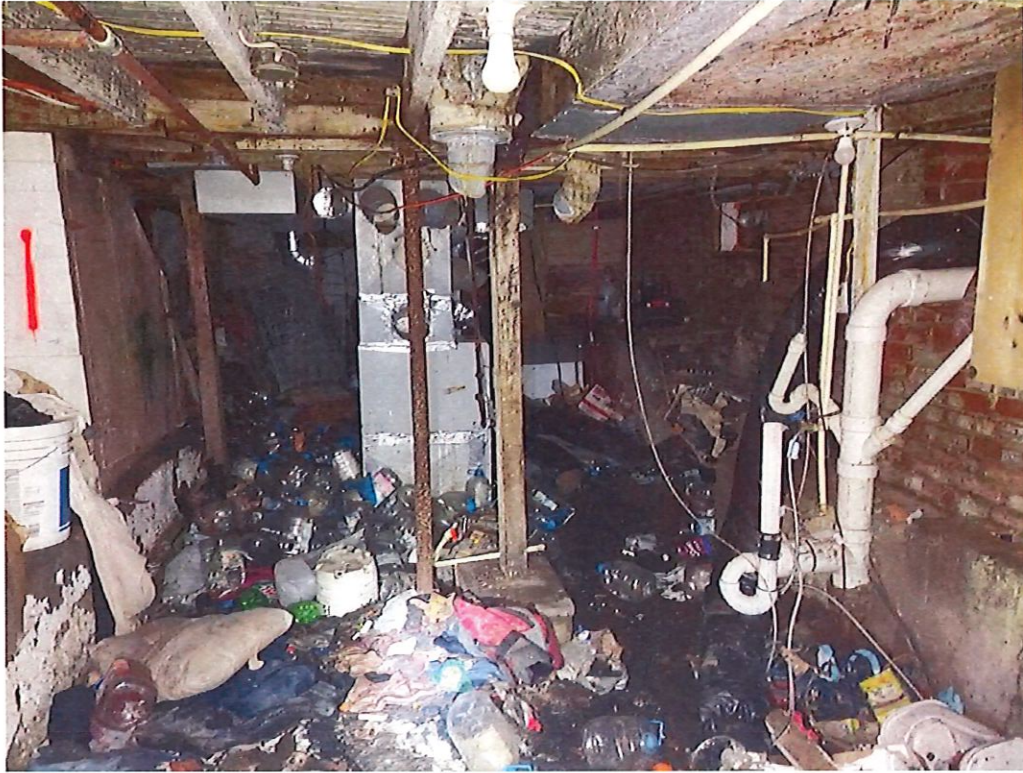
View of FS-1

ID#	MATERIAL	LOCATION	QUANTITY	RESULT	NESHAP CATEGORY
6-WG-A,B,C	Window Glaze	EA 7,8,9	3 WINDOWS	PLM 3% Chrysotile	Cat II
15-PI-A,B,C	Pipe Insulation	FS 1	10 SF	PLM 40% Chrysotile	RACM

MATERIAL	LOCATION	APPROXIMATE QUANTITY
CFC's Air Conditioners/Refrigerators/Freezers/Dehumidifiers	FS-2,5,9,11	4
CRTs/TV Screens/Monitors/Electronics	FS-12	2
Misc. Items (Glue, Solvents, Cleaners, etc.)	FS-1, FS-12	140
Natural Gas Regulator	FS-1	1

An asbestos abatement company, licensed in the State of Michigan should remove the materials identified as asbestos containing in Table I in accordance with all applicable Local, State, and Federal Requirements prior to demolition.

Other Regulated Materials/Universal Wastes, identified in Table III, must be transported and disposed in accordance with all applicable Local, State, and Federal Requirements prior to demolition.

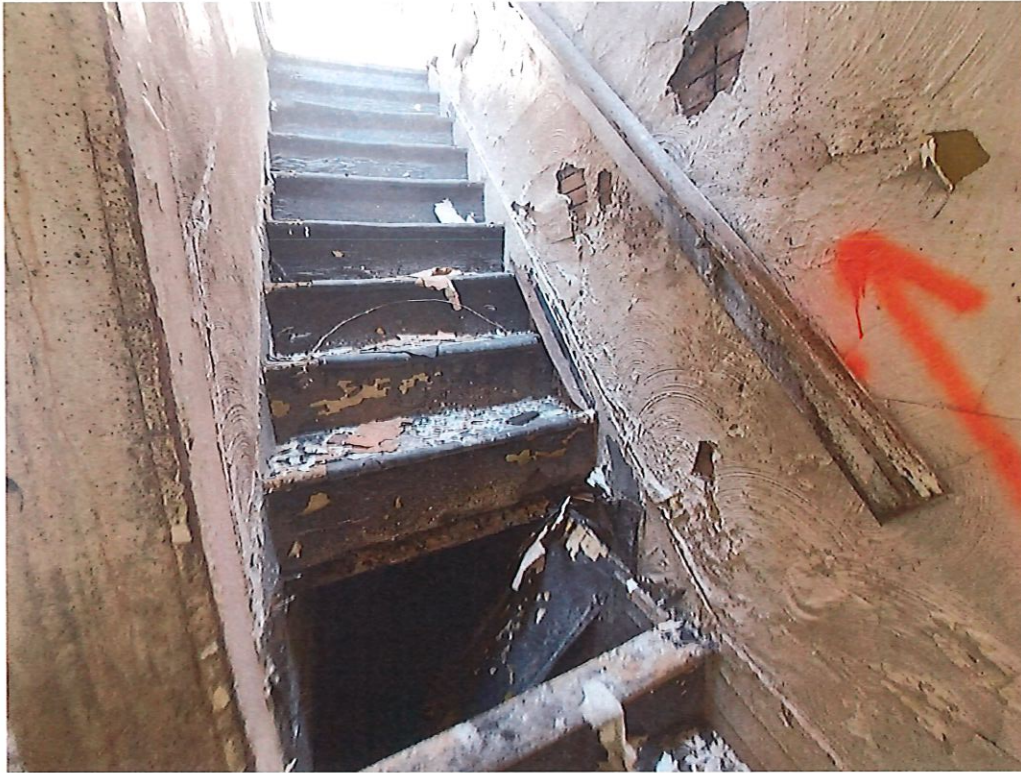
View of FS-11 (Stairs leading to 2nd floor have collapsed into the basement)
