Client Name:	City of Kalamazoo
Project Name:	Residential Asbestos Survey
Project Number:	188BS23234
Project Site Address (Subject Property):	518 W. North Street, Kalamazoo, MI 49007
Date of Site Visit:	March 31, 2023
Asbestos Inspection Performed by:	Andrew DeLodder (A48677)
Asbestos Inspector's Signature:	<i>Andrew DeLodder</i>
Areas Not Accessible:	All Areas Accessible
Number of Floors:	2 Floors with Basement and Attic
Asbestos Present (Yes/No/Other):	Yes

On the date indicated above, State of Michigan Asbestos Inspector, Andrew DeLodder (A48677) from Atlas Technical Consultants, conducted a pre-demolition asbestos and other regulated materials inspection of the subject unoccupied residential property.

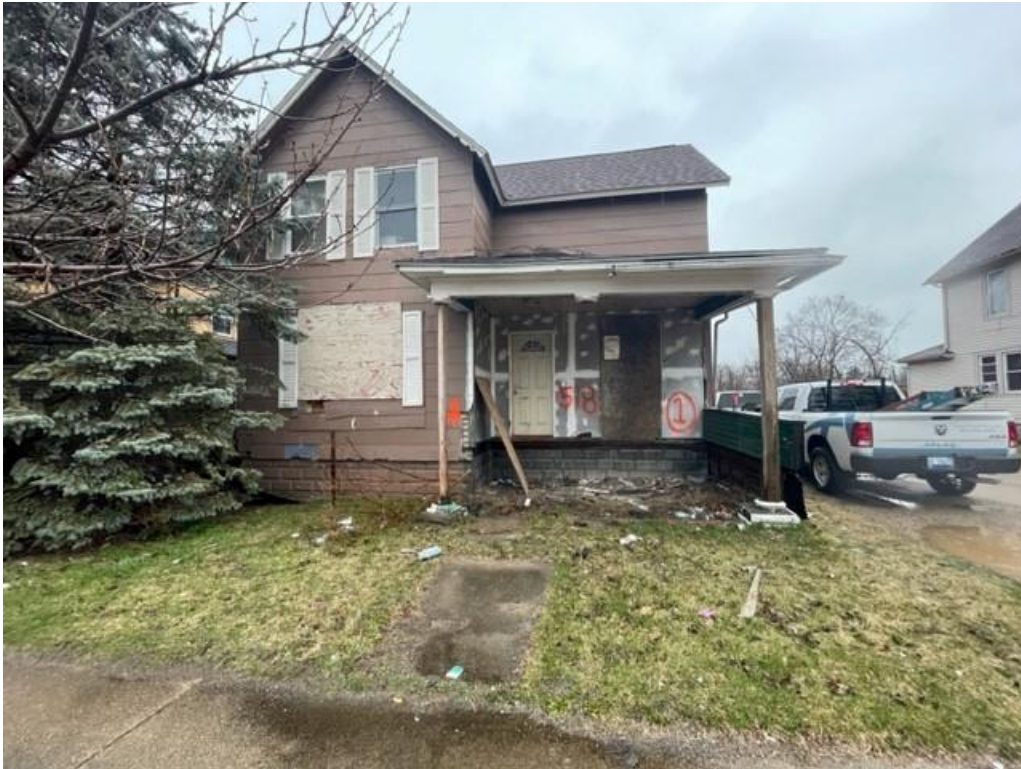
Street view of the house located at 518 N West Street (EA-1) / (EA-5)

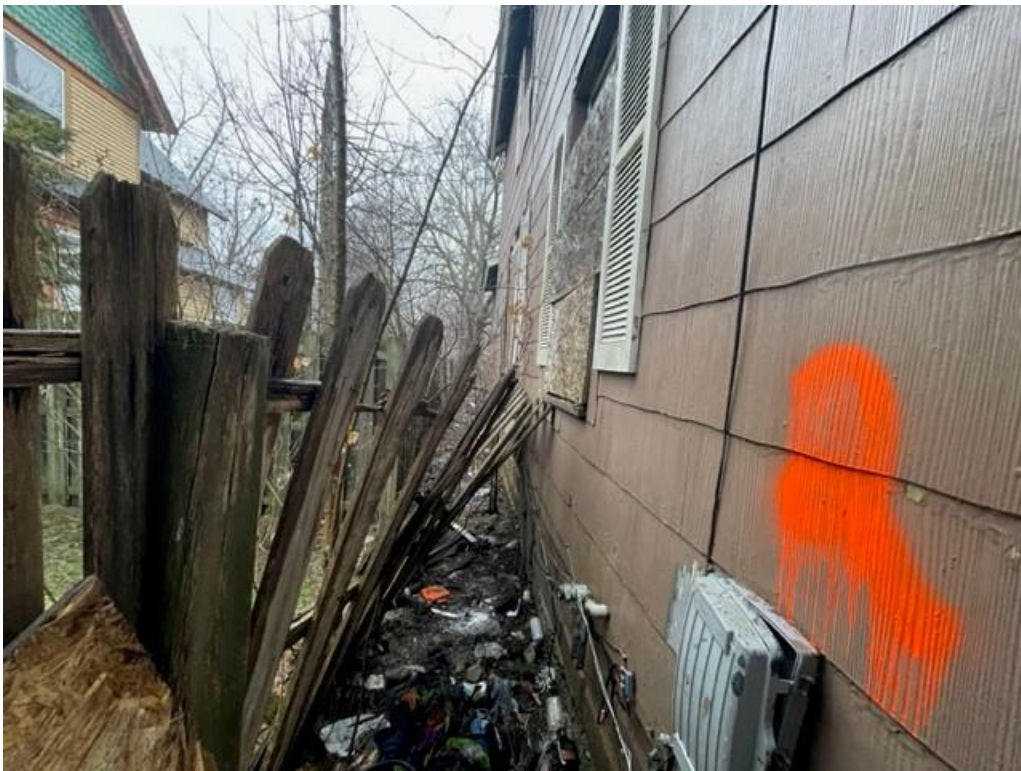
View of the left side of the house (EA-2)

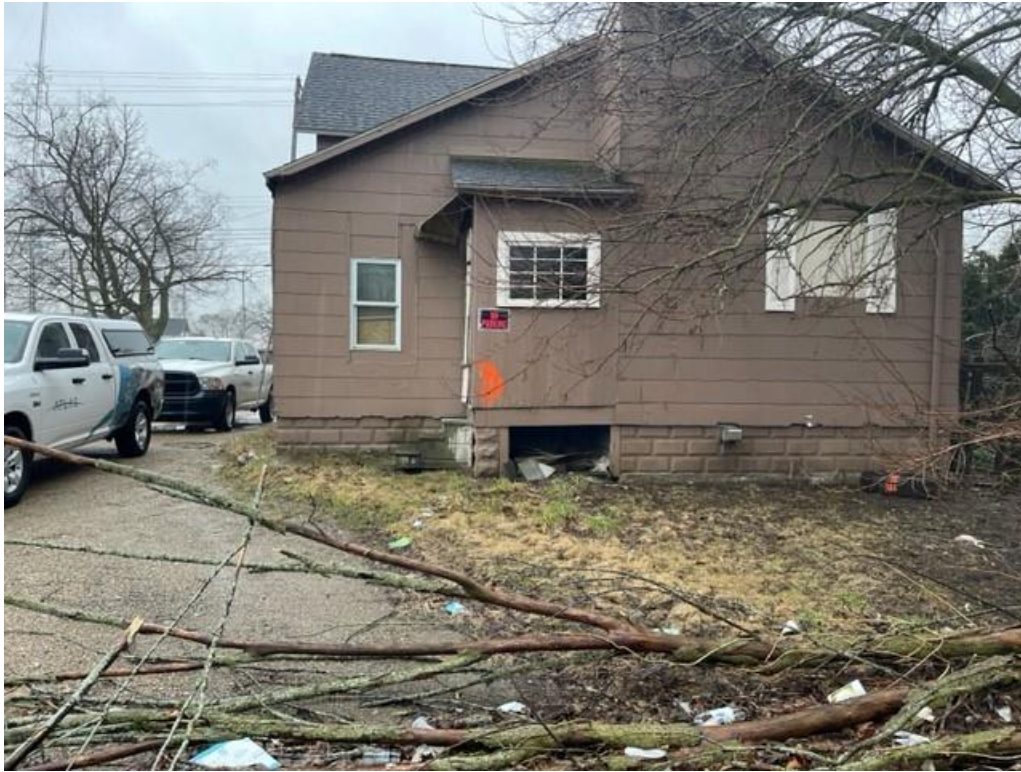
View of the rear of the house (EA-3)

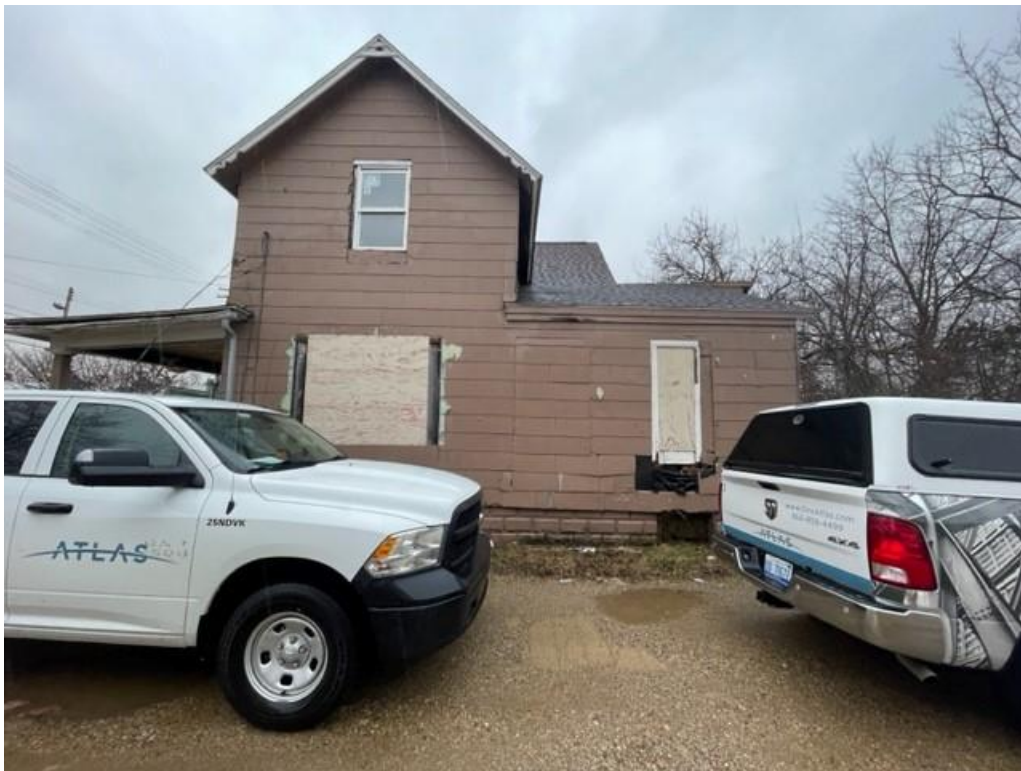
View of the right side of the house (EA-4)
