Client Name:	City of Kalamazoo
Project Name:	Commercial Building Asbestos Survey
Project Number:	188BS23419
Project Site Address (Subject Property):	750 Skinner Drive, Kalamazoo, MI 49700
Date of Site Visit:	May 24, 2023
Asbestos Inspection Performed by:	Corey Pruitt (A57116)
Asbestos Inspector's Signature:

On the date indicated above, State of Michigan Asbestos Inspector, Corey Pruitt (A57116) from Atlas Technical Consultants, conducted a pre-demolition asbestos and other regulated materials inspection of the subject unoccupied commercial property.

ASBESTOS-CONTAINING MATERIAL SURVEY  
VACANT RESIDENTIAL PROPERTY  
750 SKINNER DR  
KALAMZOO, MI 49001

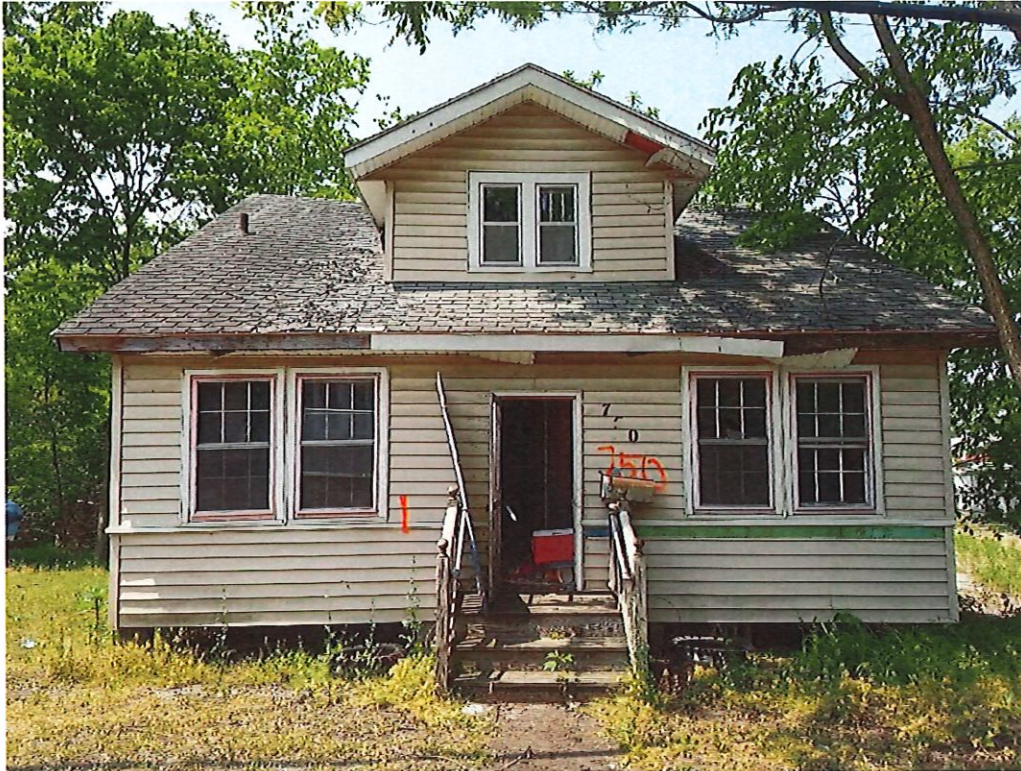
Street view of the house located at 750 Skinner Drive (EA-1) / (EA-5)

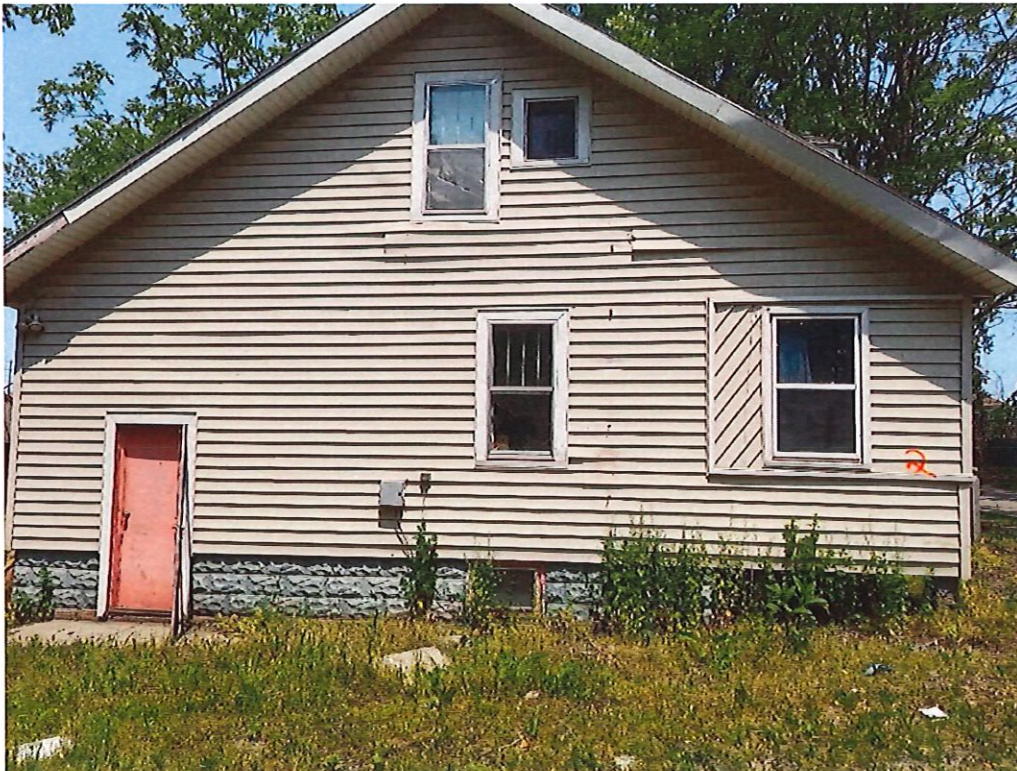
View of the left side of the house (EA-2)

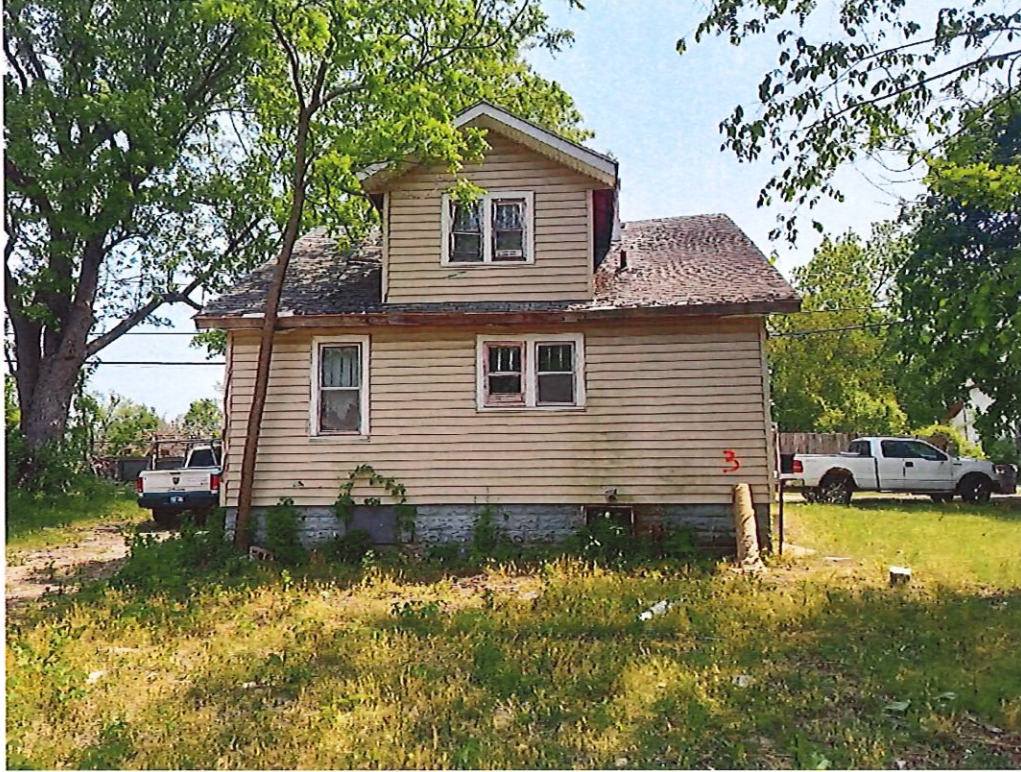
View of the rear of the house (EA-3)

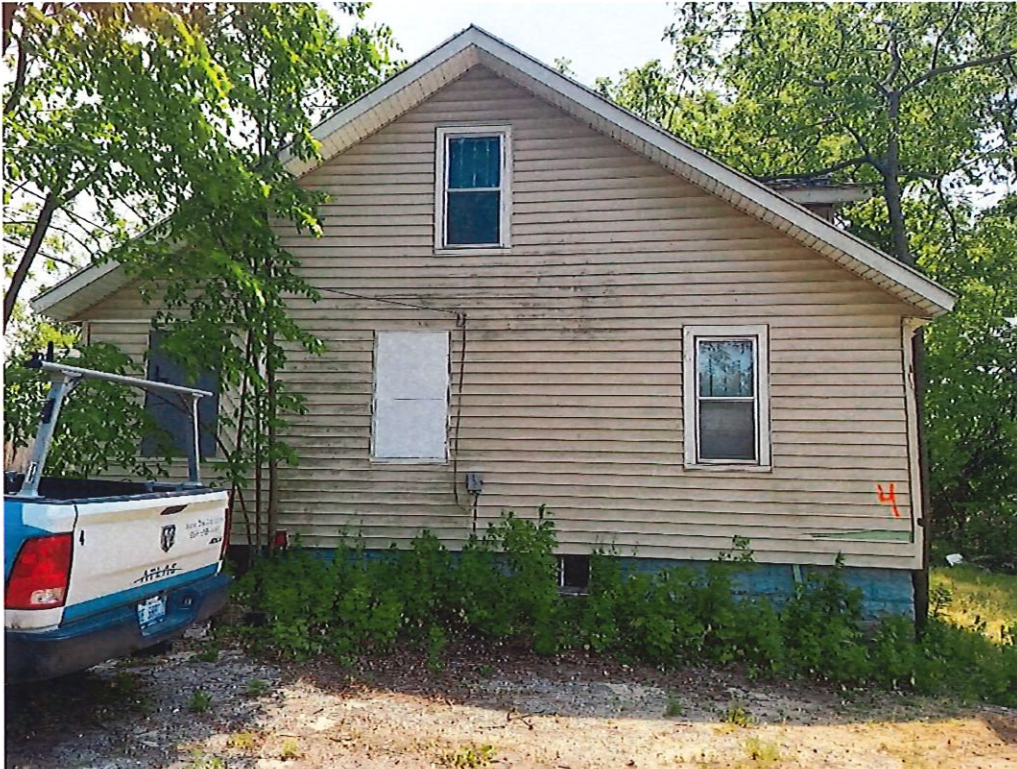
View of the right side of the house (EA-4)

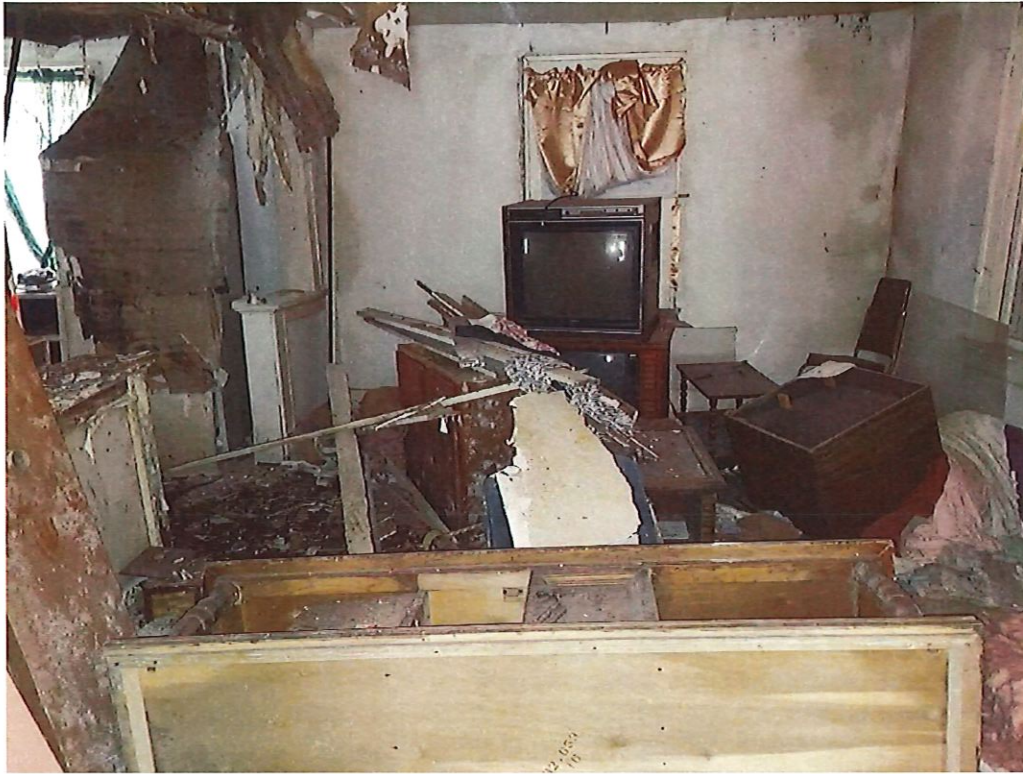
View of FS-3

MATERIAL	LOCATION	APPROXIMATE QUANTITY
CFC's Air Conditioners/Refrigerators/Freezers/Dehumidifiers	FS-4	1
CRTs/ TV Screens/ Monitors/Electronics	FS-3	2

Other Regulated Materials/Universal Wastes, identified in Table III, must be transported and disposed in accordance with all applicable Local, State, and Federal Requirements prior to demolition.
