Client Name:	City of Kalamazoo
Project Name:	Commercial Building Asbestos Survey
Project Number:	188BS23599
Project Site Address (Subject Property):	1708 N Church Street, Kalamazoo, MI 49007
Date of Site Visit:	August 25, 2023
Asbestos Inspection Performed by:	Andrew DeLodder (A48677)
Asbestos Inspector's Signature:	<i>Andrew DeLodder</i>
Areas Not Accessible:	None
Number of Floors:	1
Asbestos Present (Yes/No/Other):	No

ASBESTOS-CONTAINING MATERIAL SURVEY
VACANT RESIDENTIAL PROPERTY
1708 N CHURCH STREET
KALAMAZOO, MICHIGAN 49007

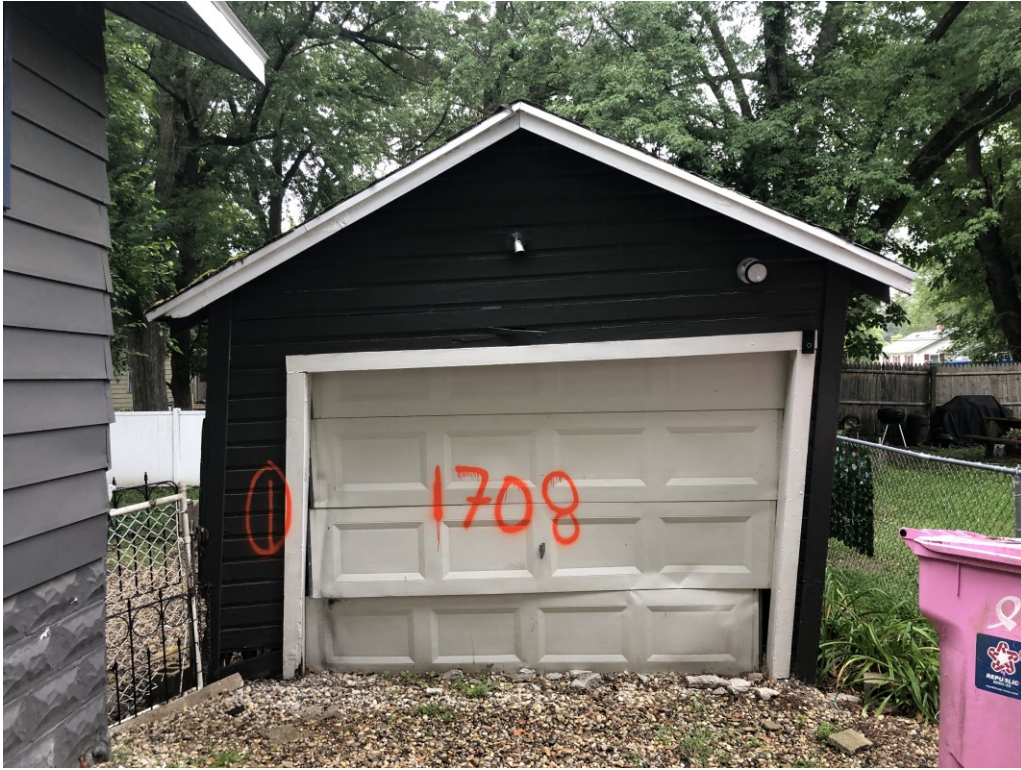
View of the west side of the garage exterior (EA-1)

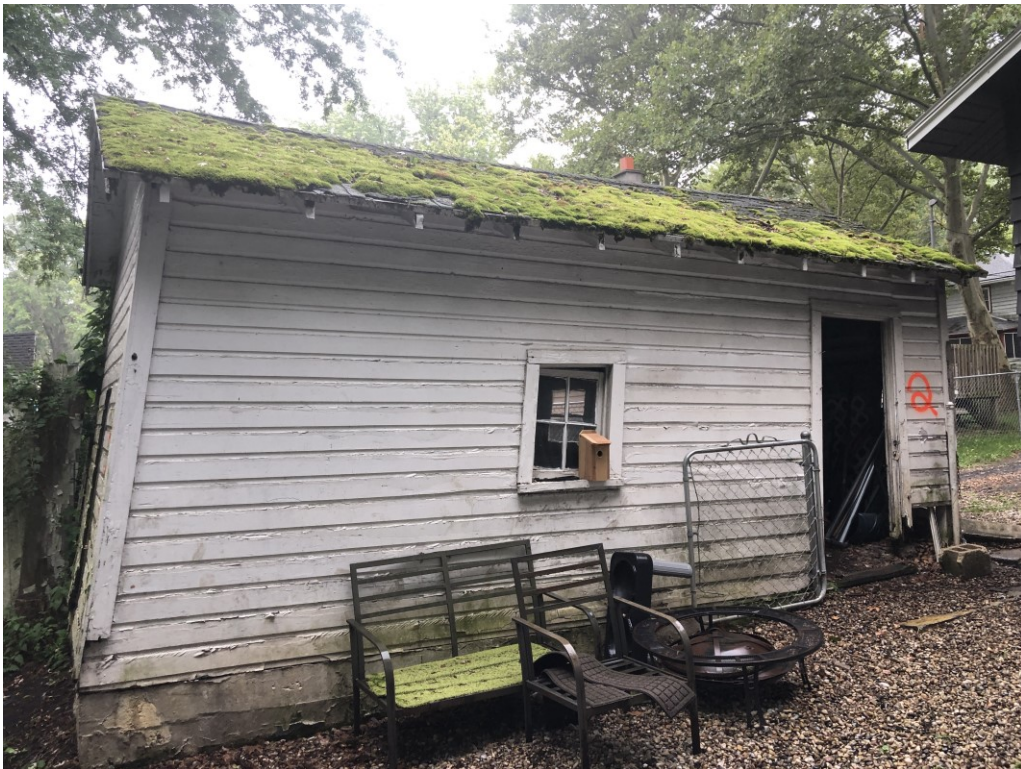
View of the north side of the garage exterior (EA-2)

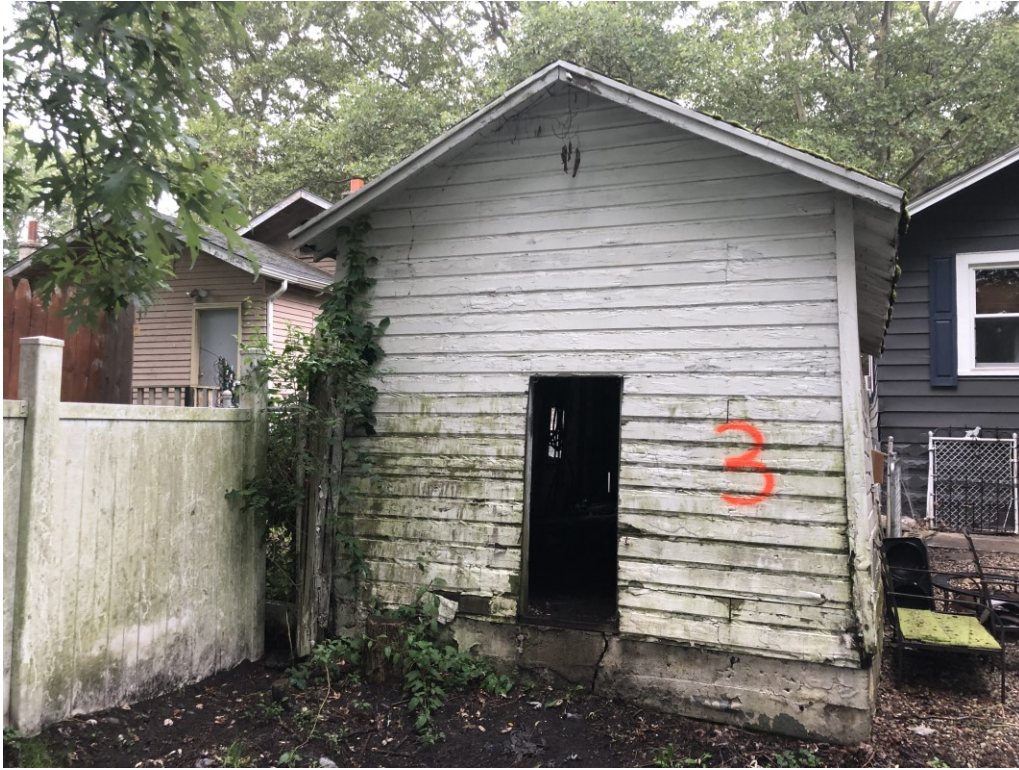
View of the east side of the garage exterior (EA-3)

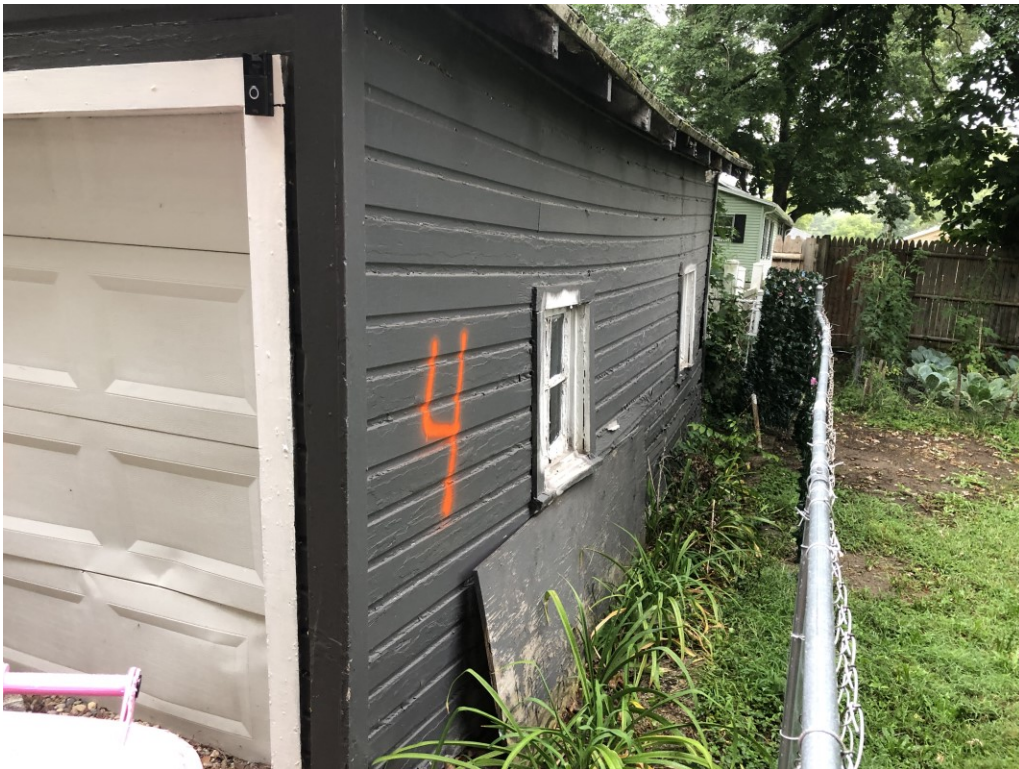
View of the south side of the garage exterior (EA-4)

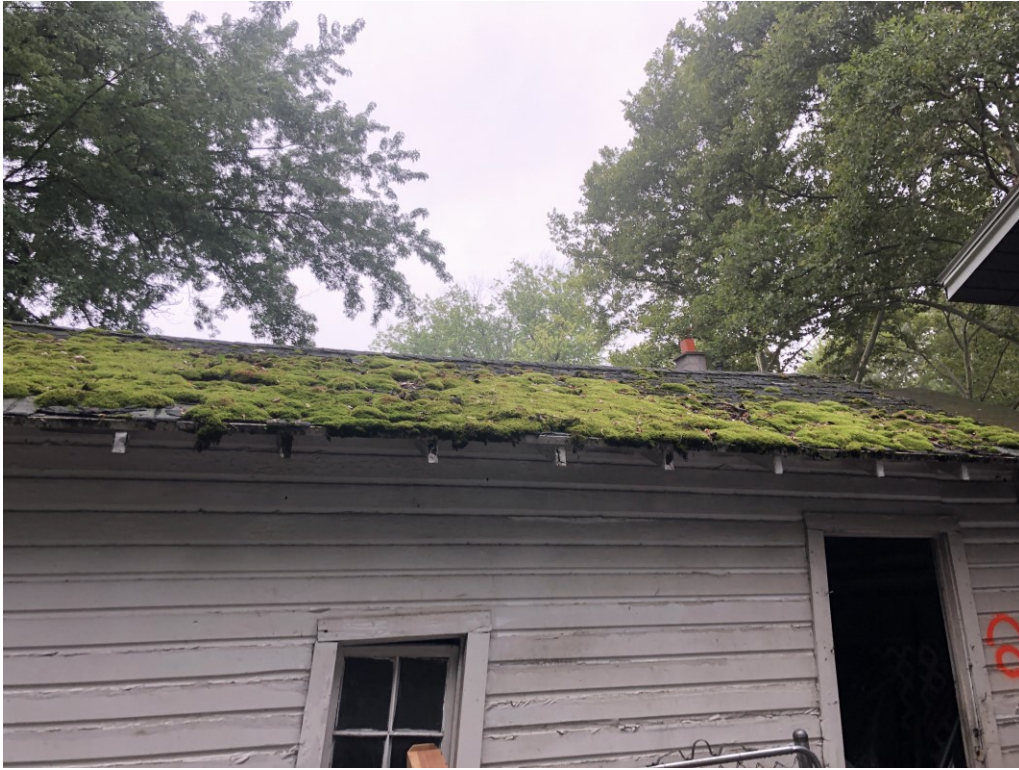
View of the garage roof (EA-5)

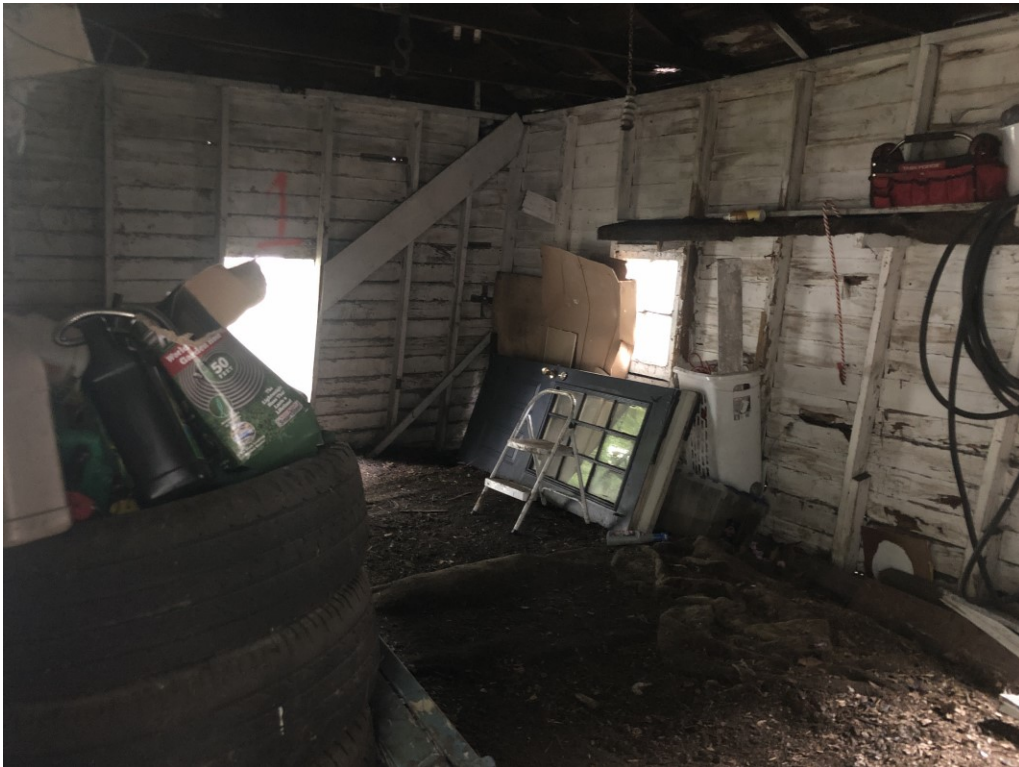
View of the garage interior (FS-1)
