Client Name:	City of Kalamazoo
Project Name:	Commercial Building Asbestos Survey
Project Number:	188BS23505
Project Site Address (Subject Property):	404 Parker Ave, Kalamazoo, MI 49001
Date of Site Visit:	July 28, 2023
Asbestos Inspection Performed by:	Andrew DeLodder (A48677)
Asbestos Inspector's Signature:	<i>Andrew DeLodder</i>
Areas Not Accessible:	None
Number of Floors:	Garage Only
Asbestos Present (Yes/No/Other):	No asbestos identified in areas surveyed.

ASBESTOS-CONTAINING MATERIAL SURVEY
VACANT RESIDENTIAL PROPERTY
404 PARKER AVENUE
KALAMAZOO, MICHIGAN 49001

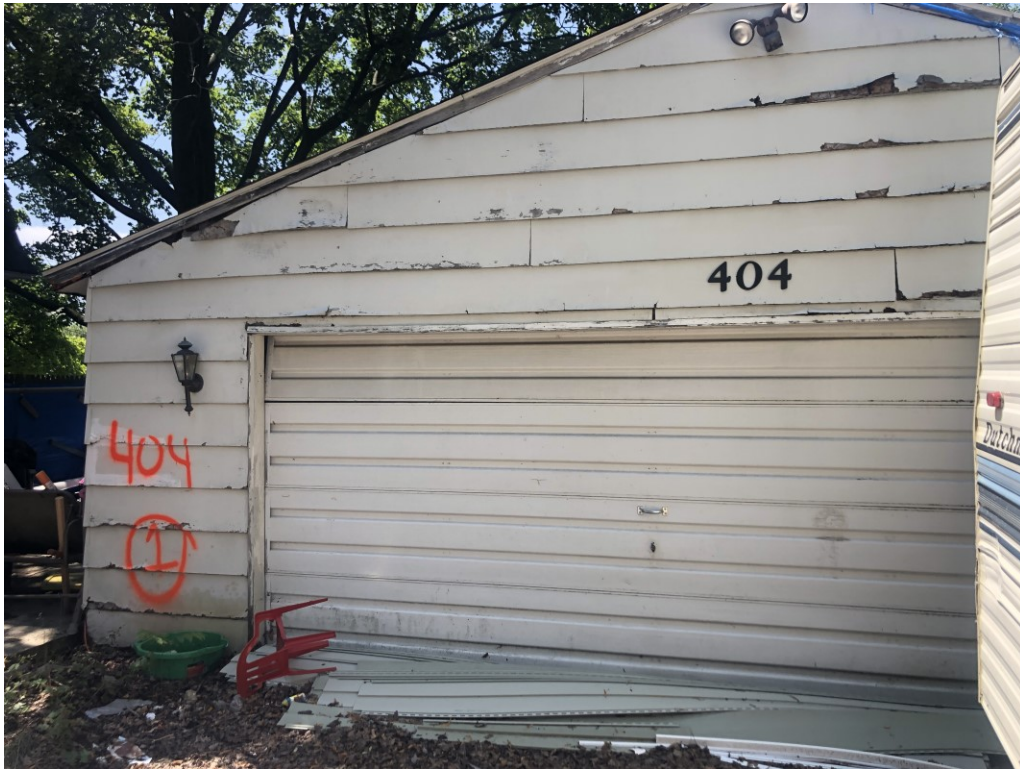
View of the east side of the garage exterior (EA-1)

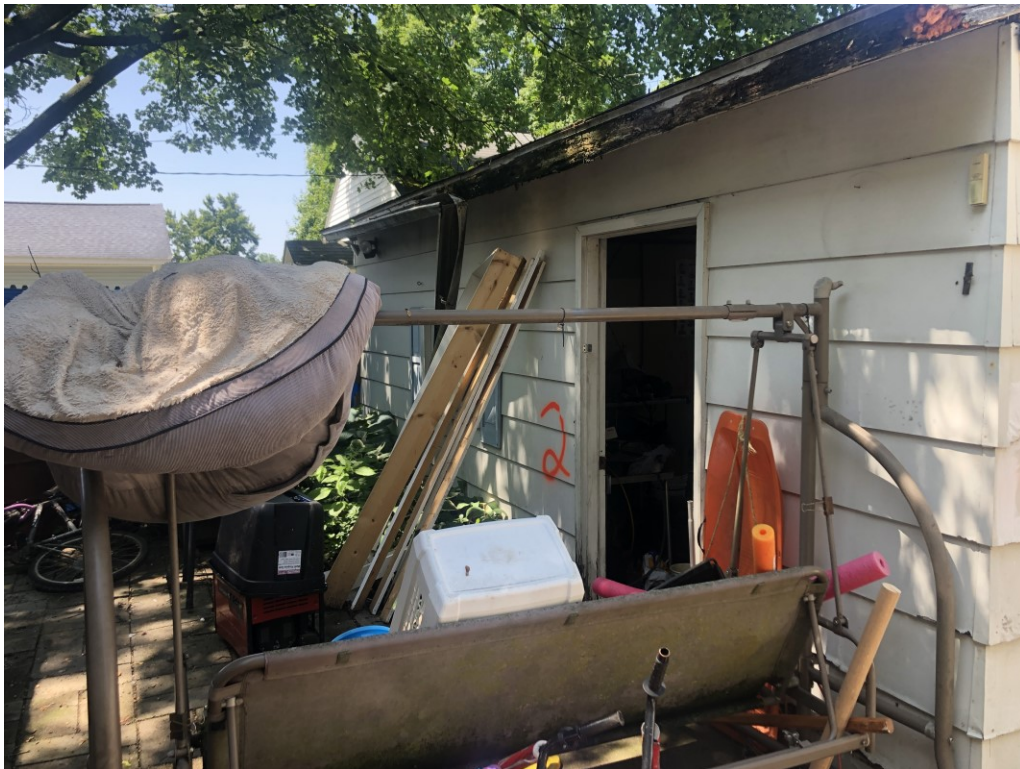
View of the south side of the garage exterior (EA-2)

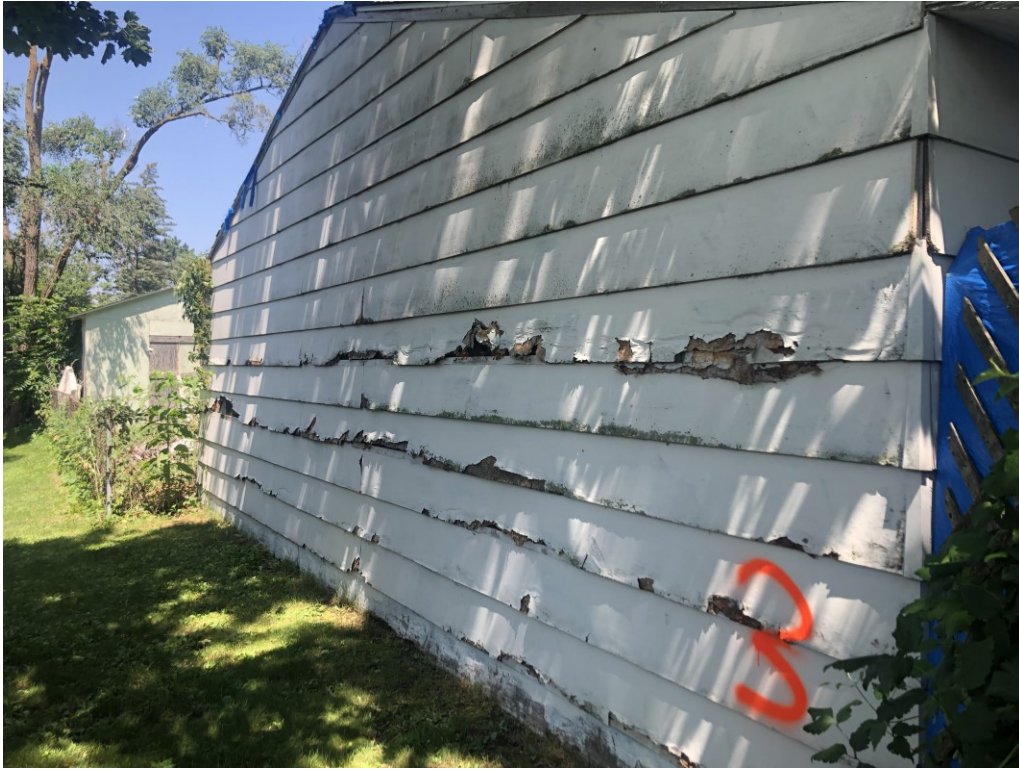
View of the west side of the garage exterior (EA-3)

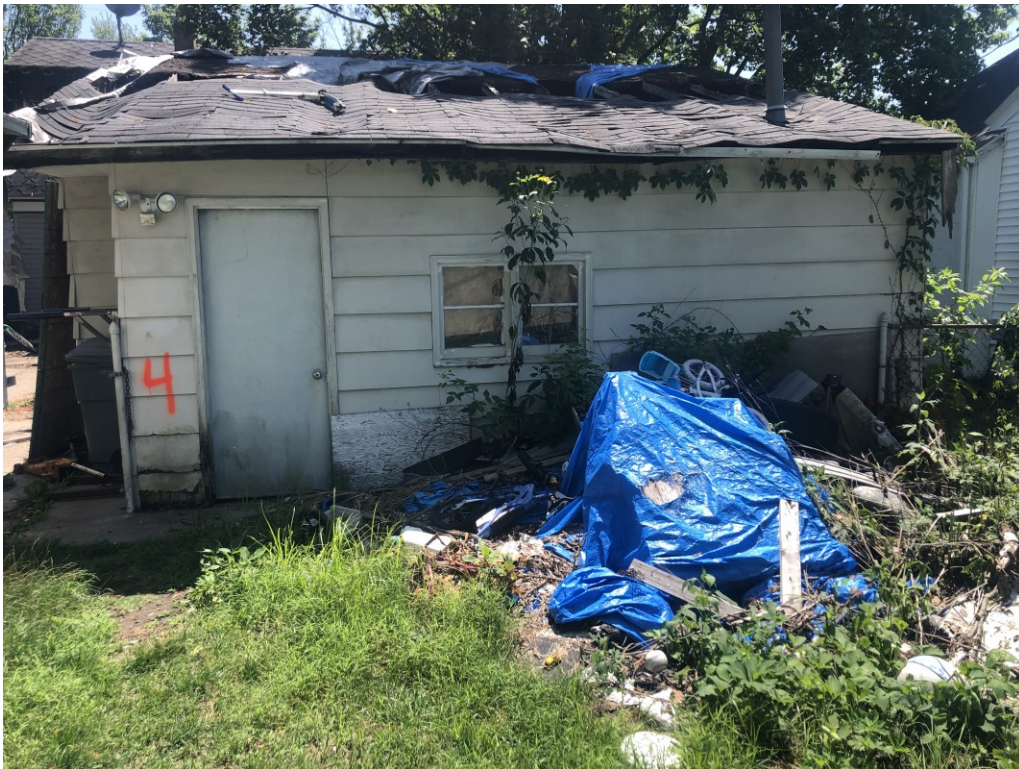
View of the north side of the garage exterior (EA-4)

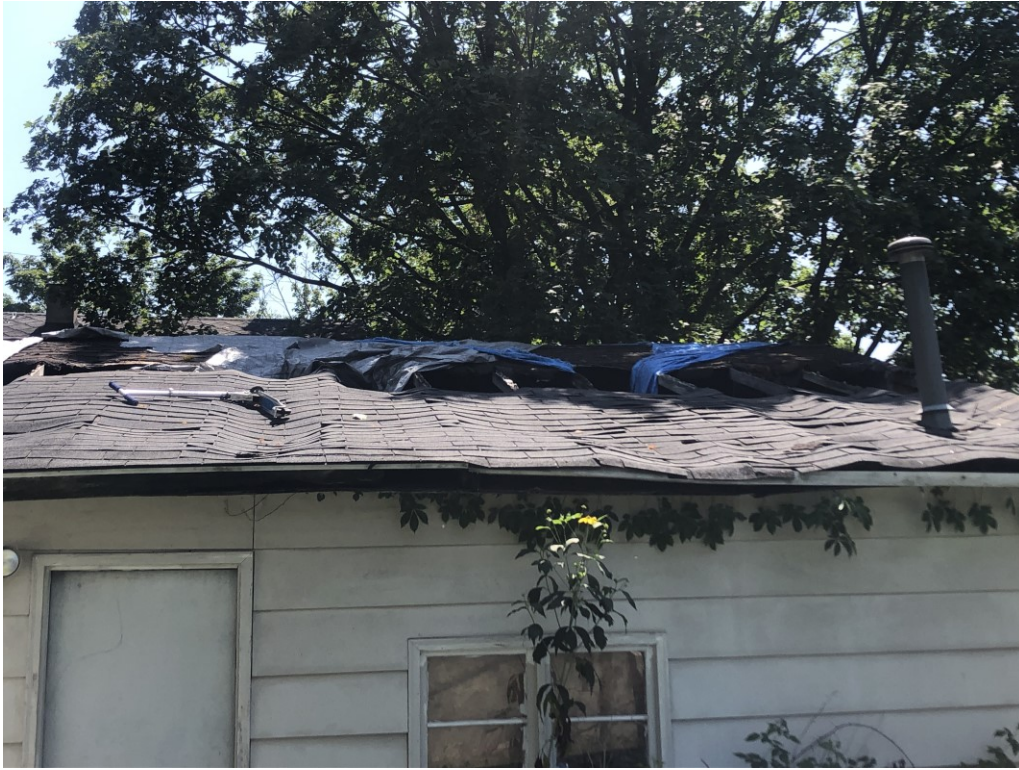
View of the garage roof (EA-5)

Roofing materials that were not tested during this inspection should be assumed to be Category I asbestos-containing roofing materials.

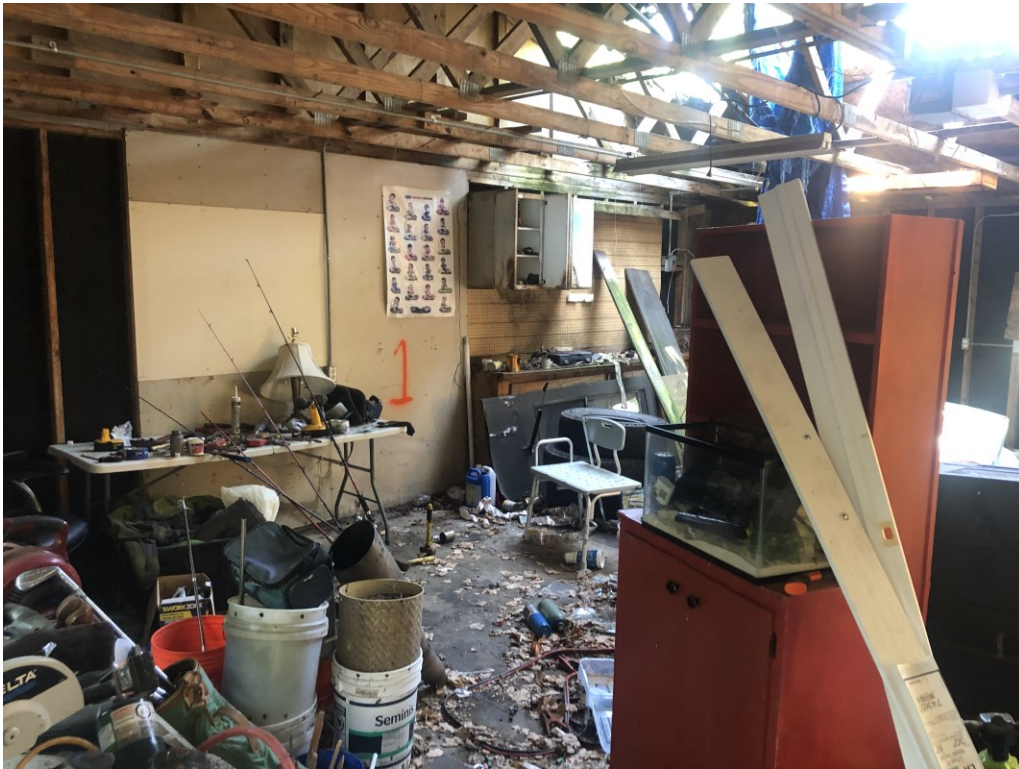
View of the garage interior (FS-1)

Other Regulated Materials/Universal Wastes, identified in Table III, must be transported and disposed in accordance with all applicable Local, State, and Federal Requirements prior to demolition.
