Client Name:	City of Kalamazoo
Project Name:	Commercial Building Asbestos Survey
Project Number:	188BS23599
Project Site Address (Subject Property):	728 W Lovell Street, Kalamazoo, MI 49007
Date of Site Visit:	August 25, 2023
Asbestos Inspection Performed by:	Andrew DeLodder (A48677)
Asbestos Inspector's Signature:	<i>Andrew DeLodder</i>
Areas Not Accessible:	None
Number of Floors:	1
Asbestos Present (Yes/No/Other):	Yes

On the date indicated above, State of Michigan Asbestos Inspector, Andrew DeLodder (A48677) from Atlas Technical Consultants, conducted a pre-demolition asbestos and other regulated materials inspection of the subject unoccupied commercial property.

ASBESTOS-CONTAINING MATERIAL SURVEY
VACANT RESIDENTIAL PROPERTY
728 W LOVELL STREET
KALAMAZOO, MICHIGAN 49007

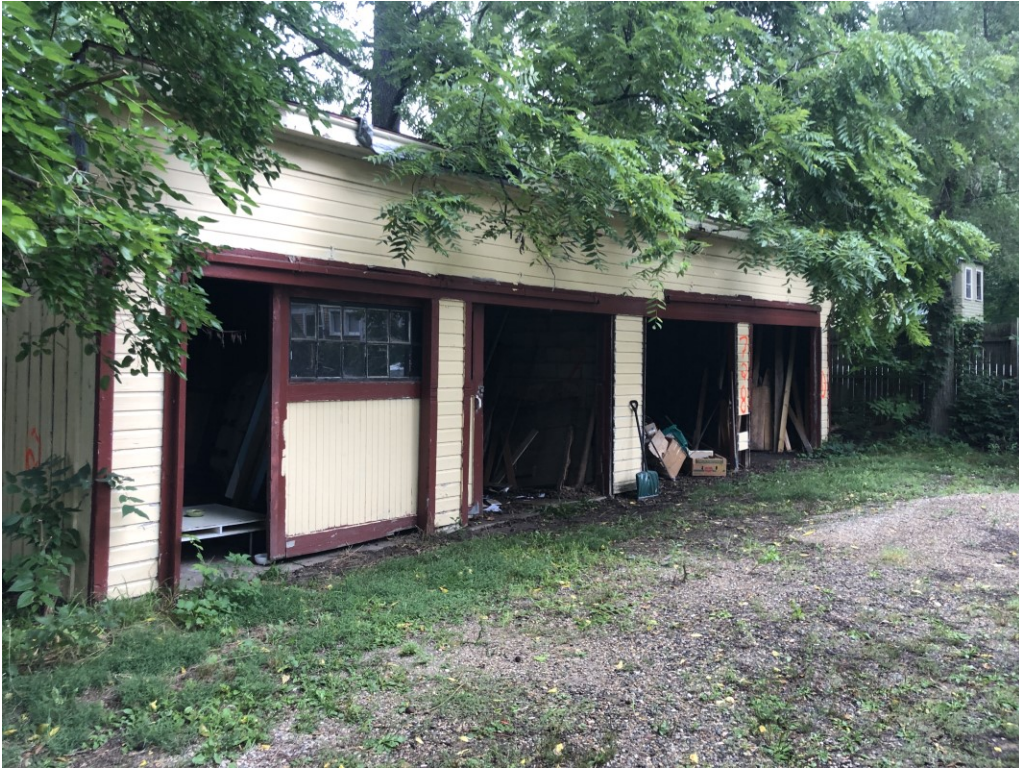
View of the south side of the garage exterior (EA-1)

ID#	MATERIAL	LOCATION	QUANTITY	RESULT	NESHAP CATEGORY
2-WG-A,B,C	Window Glaze Replacement, Gray, Wooden Multi-Pane Windows	EA-1, FS-2	3 Windows	PLM 2% Chrysotile	Cat I

An asbestos abatement company, licensed in the State of Michigan should remove the materials identified as asbestos containing in Table I in accordance with all applicable Local, State, and Federal Requirements prior to demolition.
