Client Name:	City of Kalamazoo
Project Name:	Commercial Building Asbestos Survey
Project Number:	188BS23505
Project Site Address (Subject Property):	1224 Egleston, Kalamazoo, MI 49001
Date of Site Visit:	July 28, 2023
Asbestos Inspection Performed by:	Andrew DeLodder (A48677)
Asbestos Inspector's Signature:	<i>Andrew DeLodder</i>
Areas Not Accessible:	None
Number of Floors:	Garage Only
Asbestos Present (Yes/No/Other):	No asbestos identified in areas surveyed.

ASBESTOS-CONTAINING MATERIAL SURVEY  
VACANT RESIDENTIAL PROPERTY  
1224 EGLESTON AVENUE  
KALAMAZOO, MICHIGAN 49001

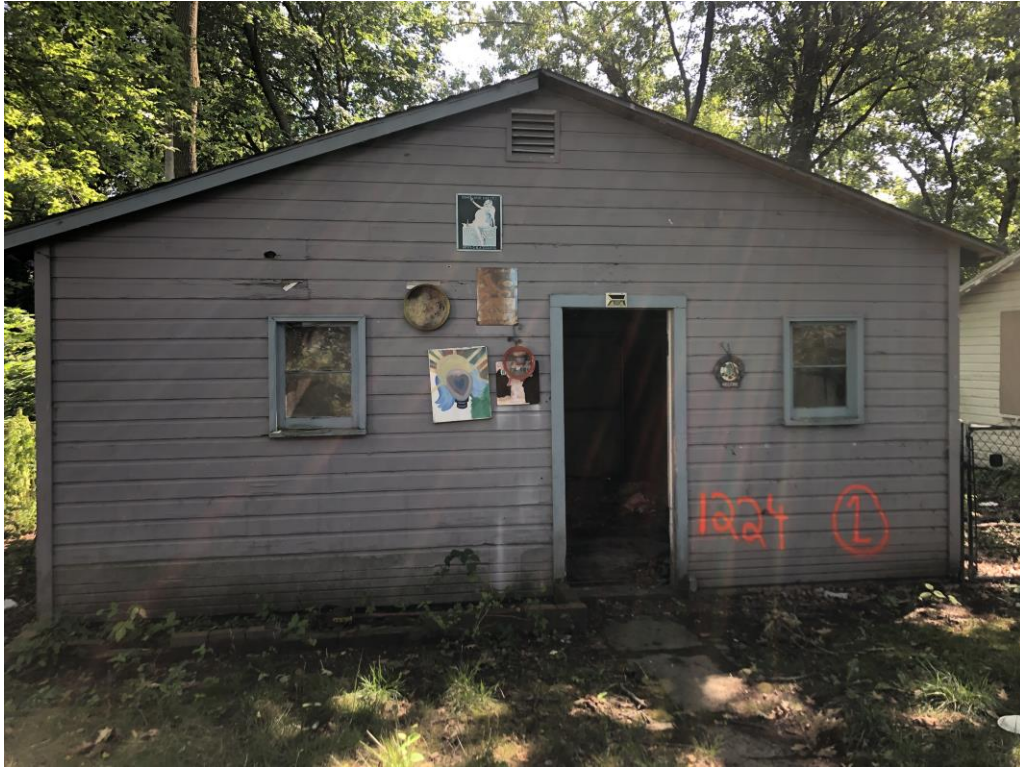
HA/ID#	MATERIAL	LOCATION	RESULT
1-RM-A,B,C	Roofing Material- Asphalt Shingle, Greenish-Blue Debris in Garage Interior	FS-1, EA-5	ND
2-BM-A,B,C	Brick Mortar- Brick Garden Wall	EA-1	ND
3-VP-A,B,C	Vapor Paper- Roll of Black Vapor Paper in Garage Interior	FS-1	ND
4-WB-A,B,C	Wallboard- on Garage Interior Walls	FS-1	ND
5-FRB-A,B,C	Fiberboard- Garage overhead Roll-Up Door Board, Rough Texture	EA-3	ND
6-CC-A,B,C	Concrete Chip- Poured Concrete Foundation	FS-1	ND

View of the north side of the garage exterior (EA-1)

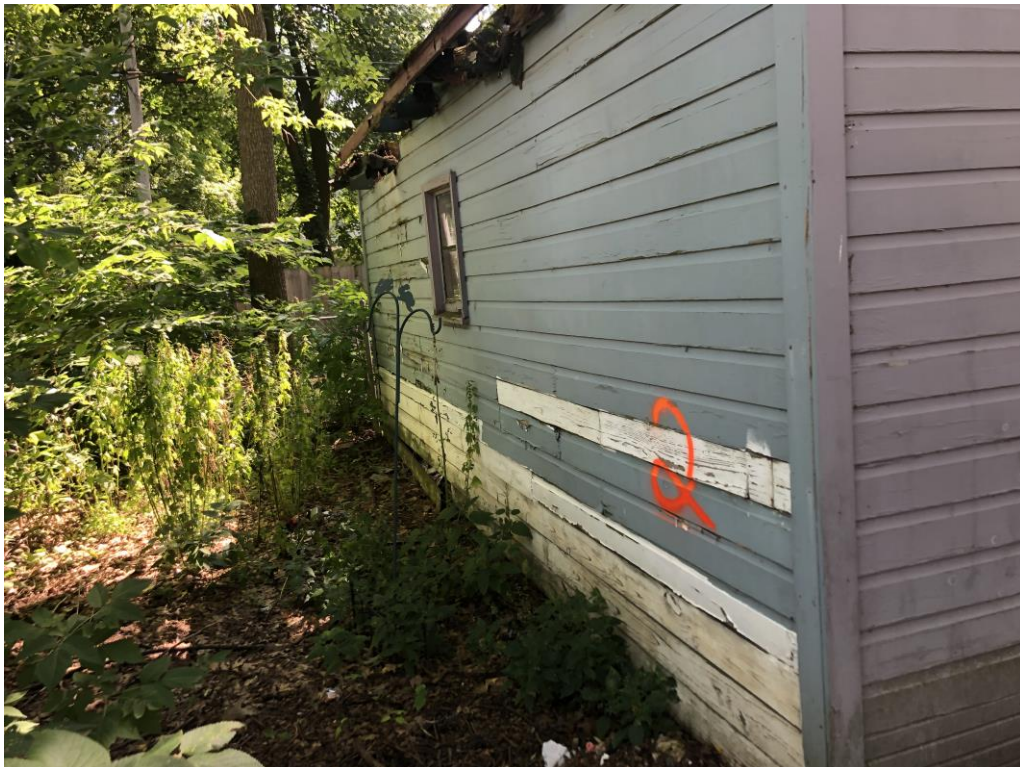
View of the east side of the garage exterior (EA-2)

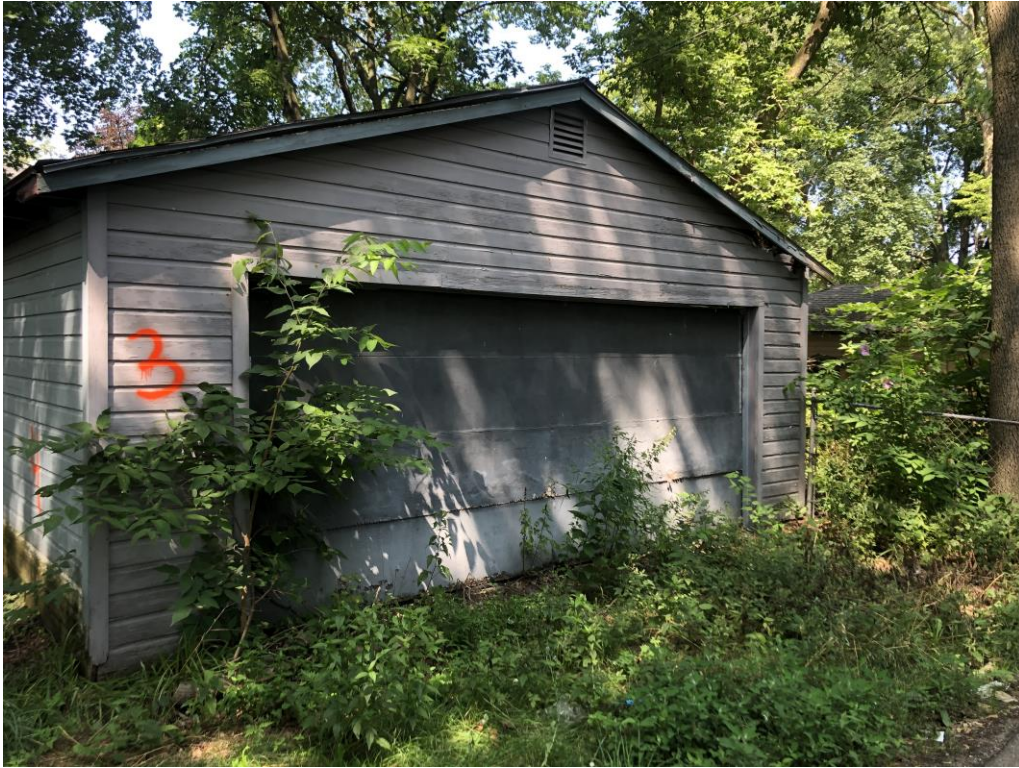
View of the south side of the garage exterior (EA-3)

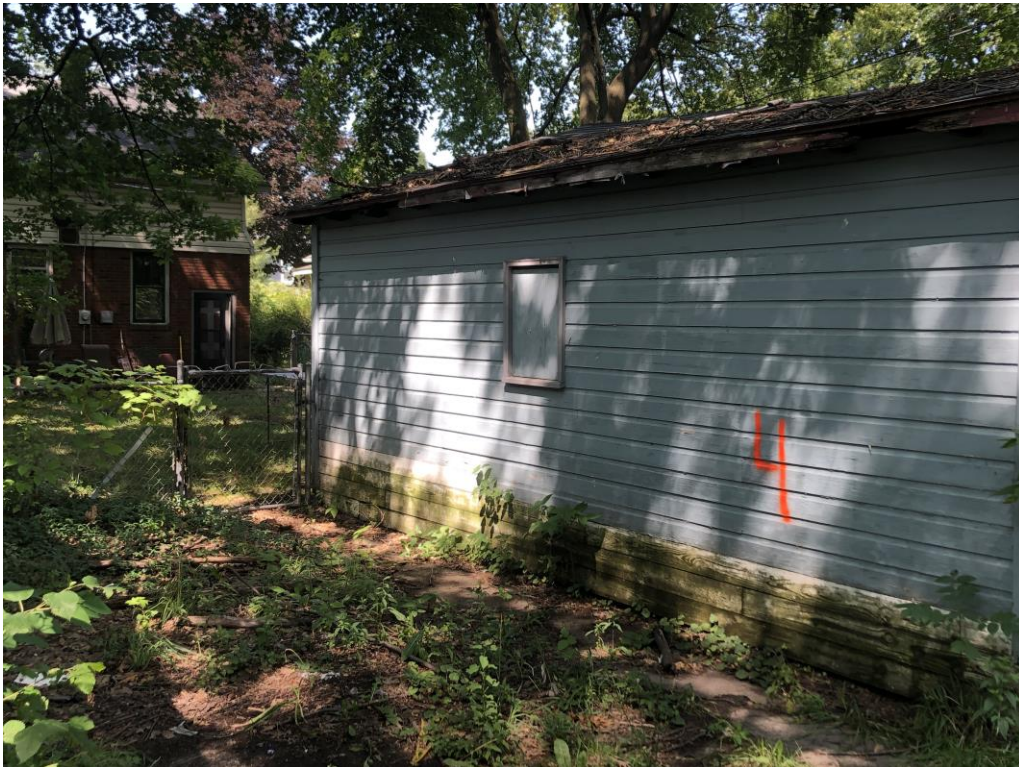
View of the west side of the garage exterior (EA-4)

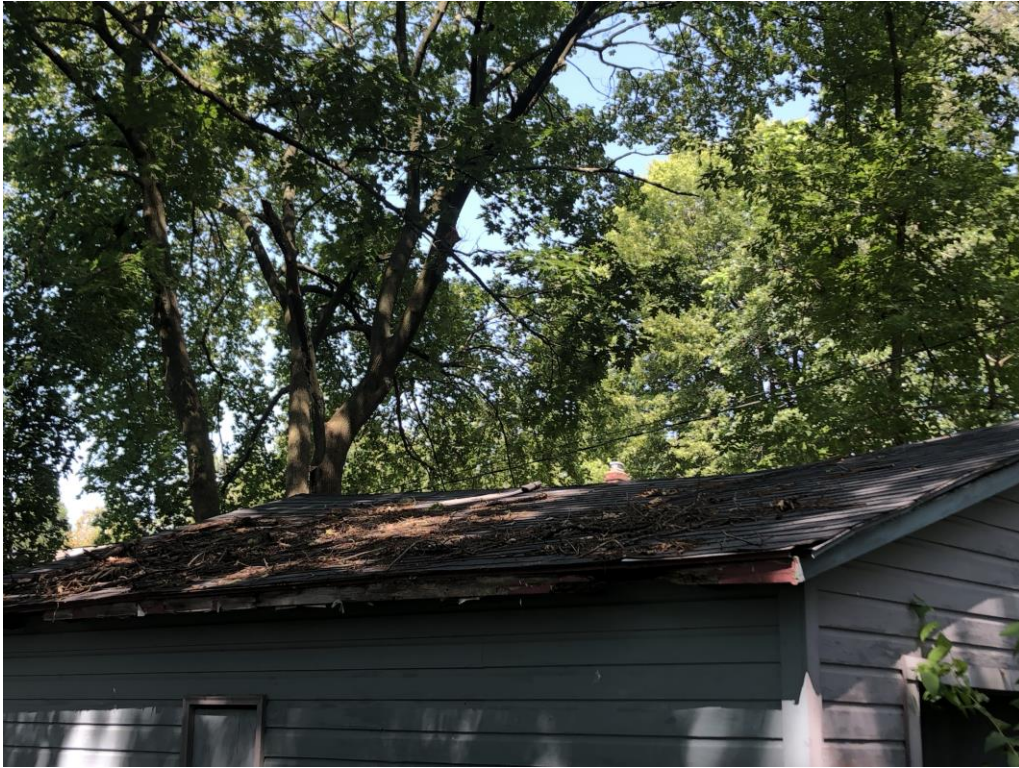
View of the garage roof (EA-5)

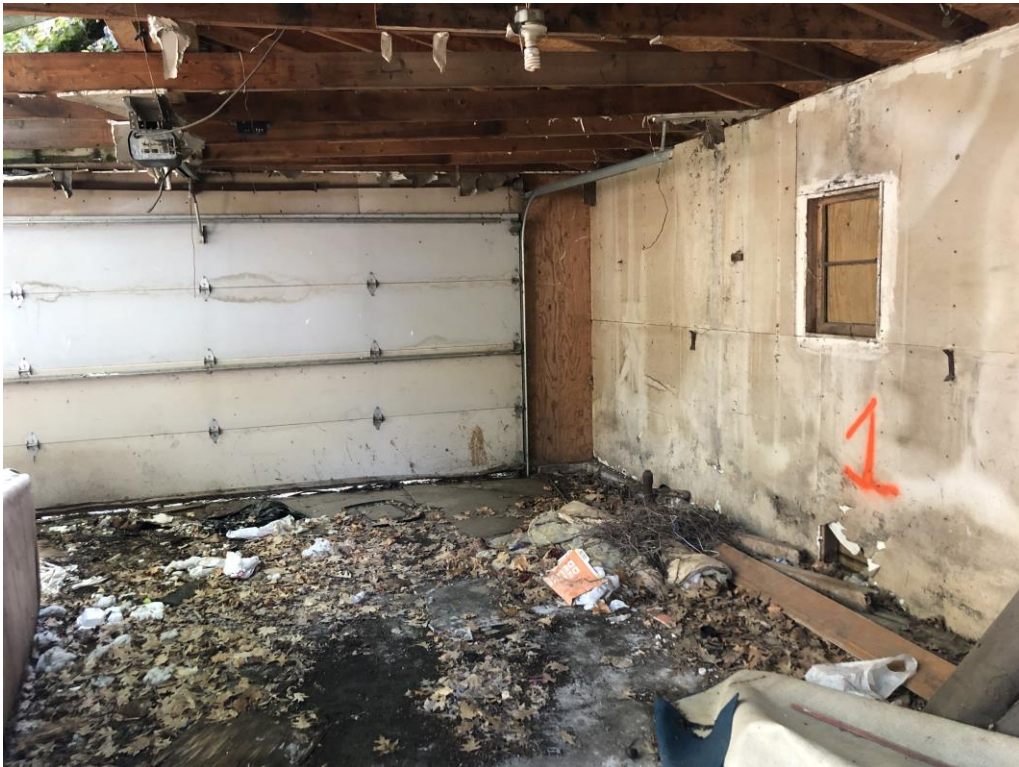
MATERIAL	LOCATION	APPROXIMATE QUANTITY
Misc. Items (Glue, Solvents, Cleaners, etc.)	FS-1	5
Paint Cans	FS-1	3
Tires	FS-1	2

View of the garage interior (FS-1)

Other Regulated Materials/Universal Wastes, identified in Table III, must be transported and disposed in accordance with all applicable Local, State, and Federal Requirements prior to demolition.
