Client Name:	City of Kalamazoo
Project Name:	Commercial Building Asbestos Survey
Project Number:	188BS23505
Project Site Address (Subject Property):	1216 Clinton Avenue, Kalamazoo, MI 49001
Date of Site Visit:	July 28, 2023
Asbestos Inspection Performed by:	Andrew DeLodder (A48677)
Asbestos Inspector's Signature:	<i>Andrew DeLodder</i>
Areas Not Accessible:	Garage Interior
Number of Floors:	Garage Only
Asbestos Present (Yes/No/Other):	Yes.

ASBESTOS-CONTAINING MATERIAL SURVEY
VACANT RESIDENTIAL PROPERTY
1216 CLINTON AVENUE
KALAMAZOO, MICHIGAN 49001

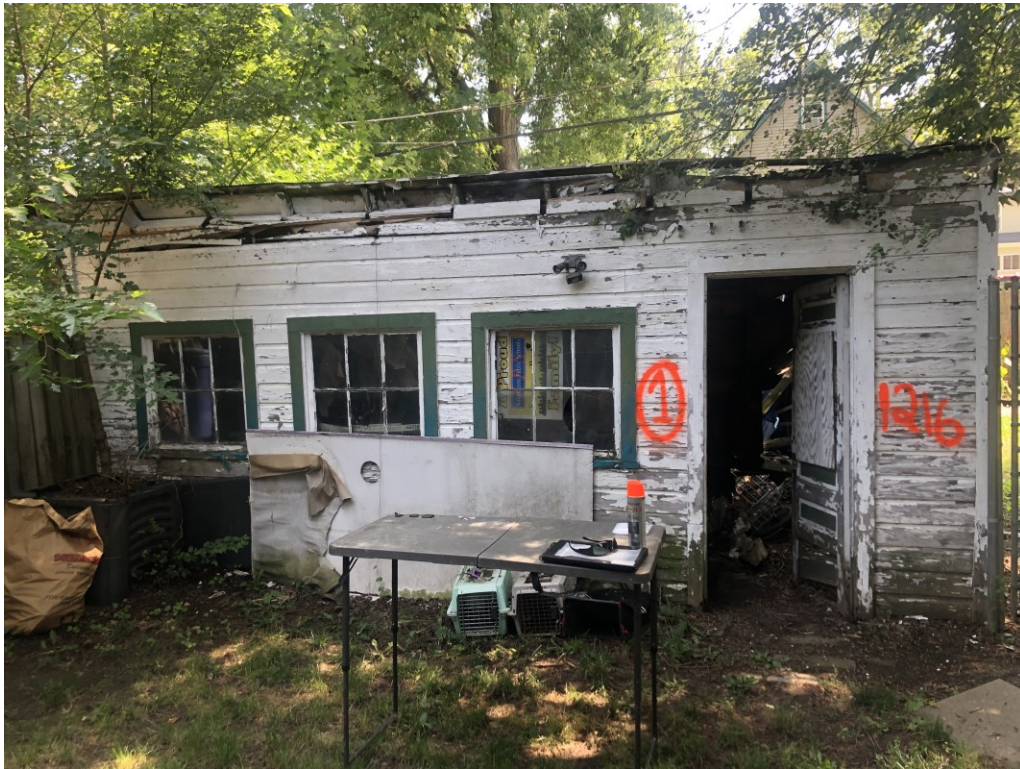
View of the north side of the garage exterior (EA-1)

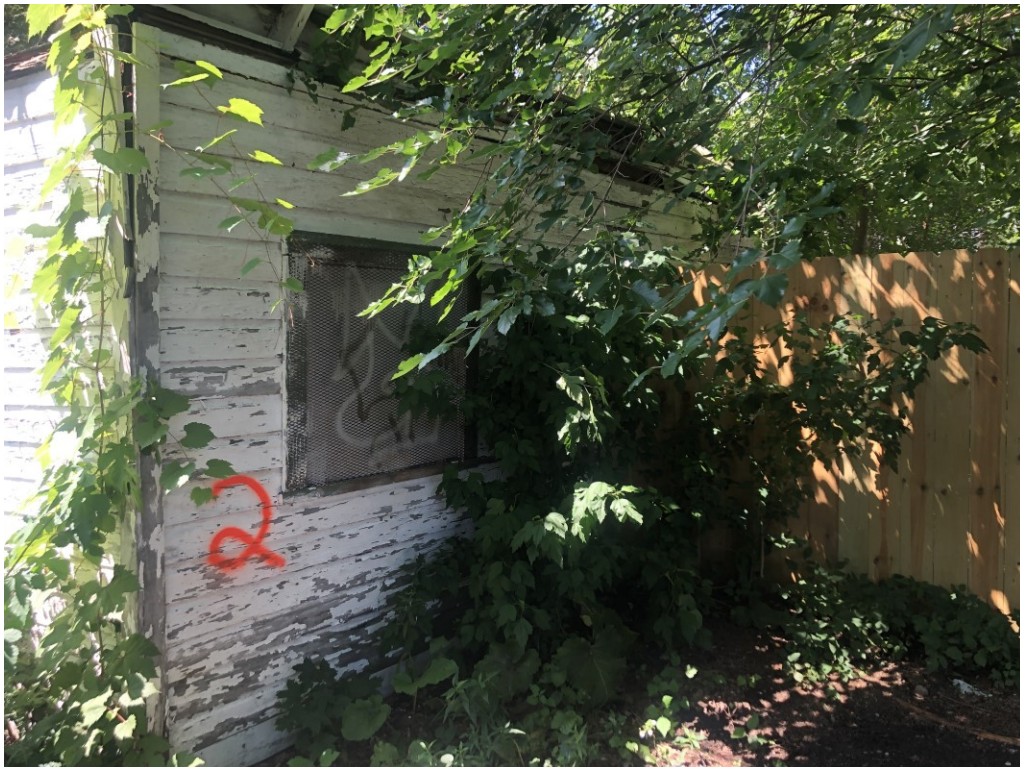
View of the east side of the garage exterior (EA-2)

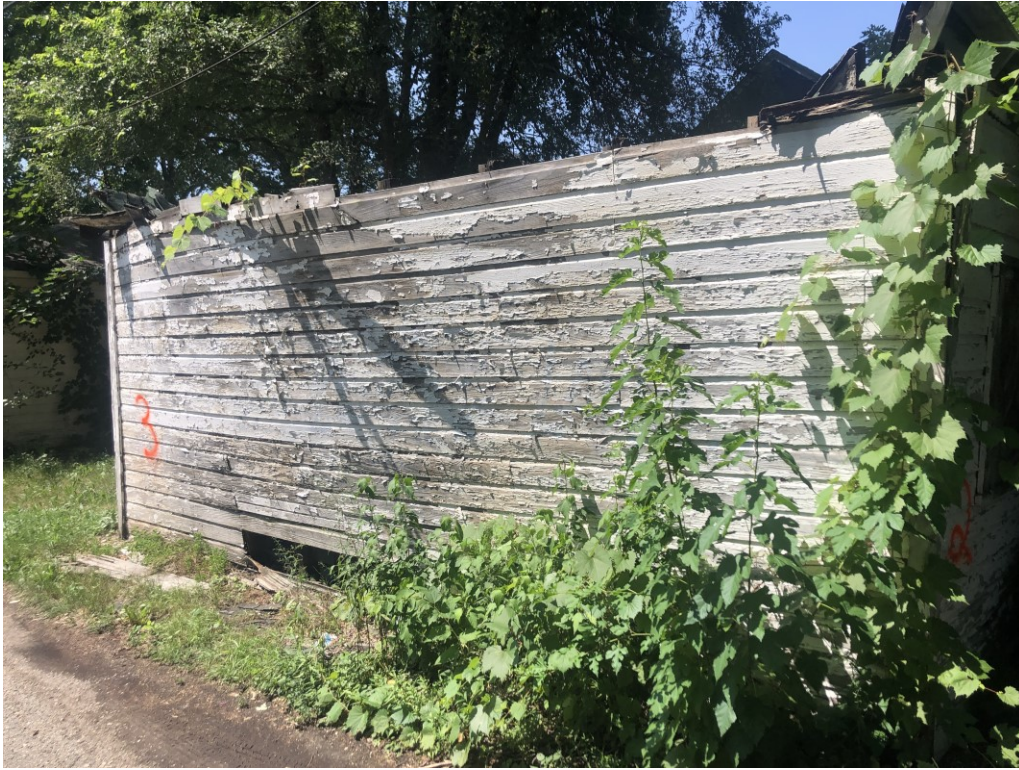
View of the south side of the garage exterior (EA-3)

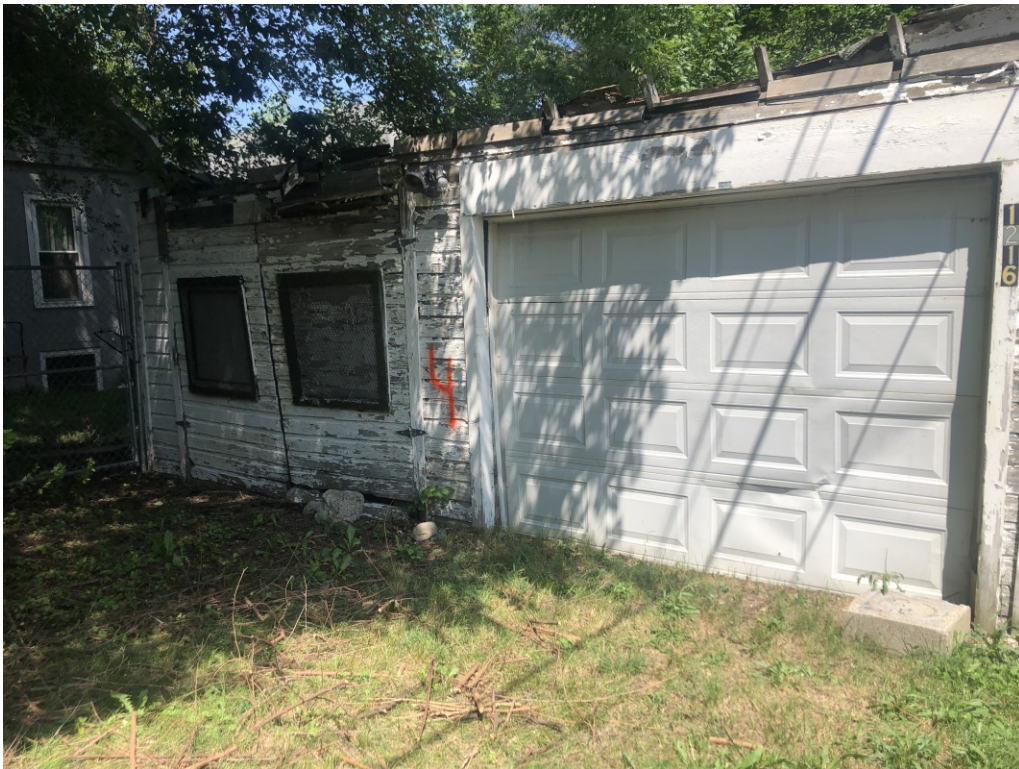
View of the west side of the garage exterior (EA-4)

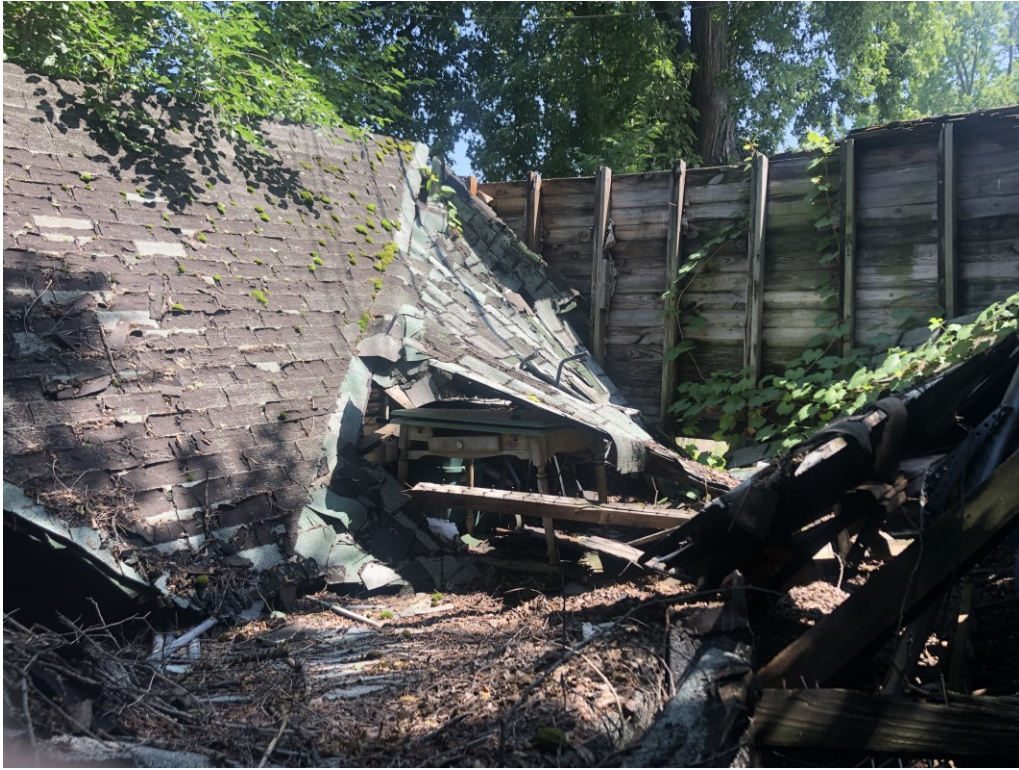
View of the garage interior (FS-1)
