Client Name:	City of Kalamazoo
Project Name:	Residential Asbestos Survey
Project Number:	188BS24020
Project Site Address (Subject Property):	1344 East Main Street, Kalamazoo, Michigan 49048
Date of Site Visit:	January 12, 2024
Asbestos Inspection Performed by:	Andrew DeLodder (A48677)
Asbestos Inspector's Signature:	<i>Andrew DeLodder</i>
Areas Not Accessible:	Entire Interior of House
Number of Floors:	2
Asbestos Present (Yes/No/Other):	Yes

ASBESTOS-CONTAINING MATERIAL SURVEY
VACANT RESIDENTIAL PROPERTY
1344 EAST MAIN STREET
KALAMAZOO, MI 49048

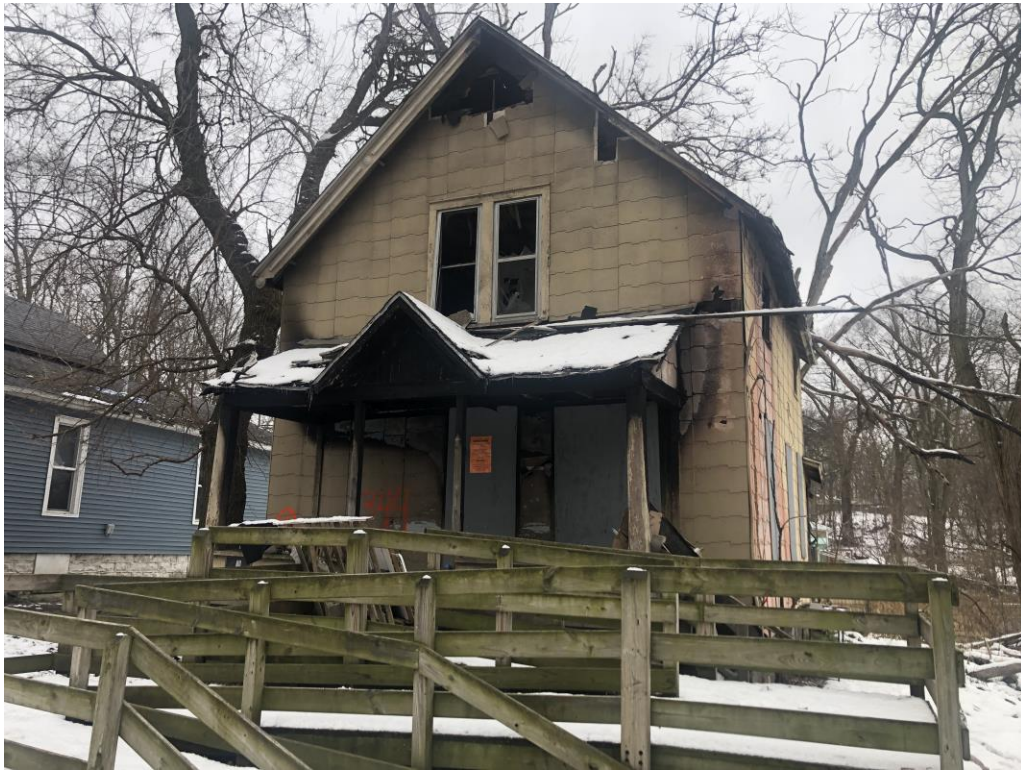
Street view of the house located at 1344 East Main Street (EA-1)

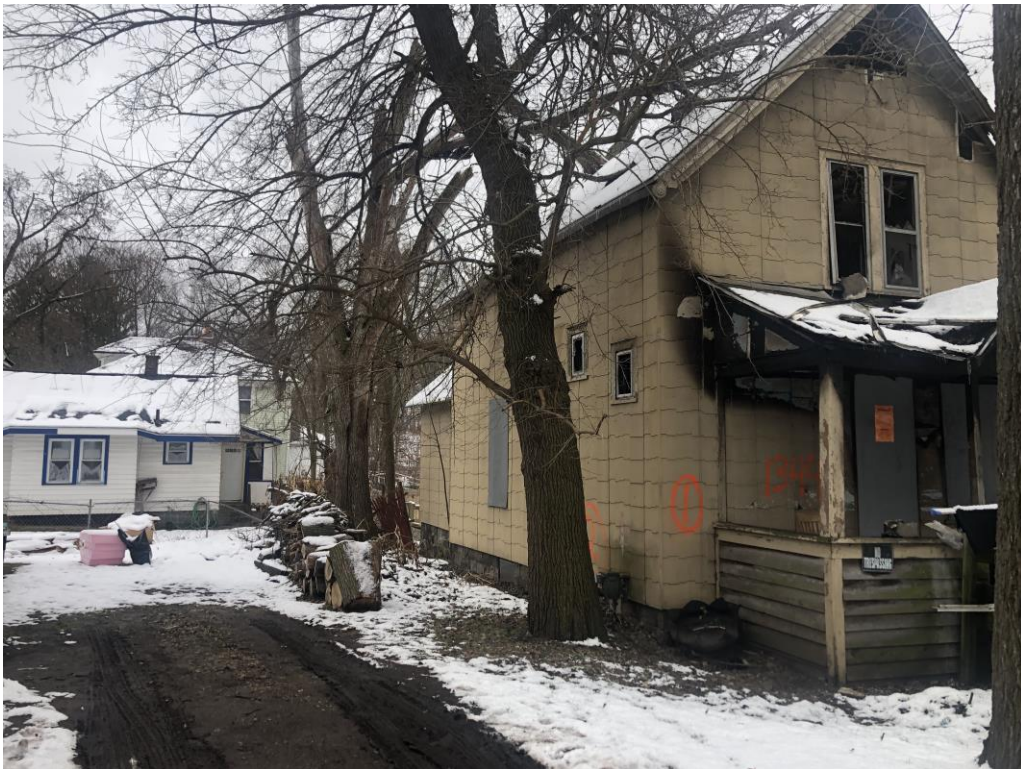
View of the left side of the house (EA-2)

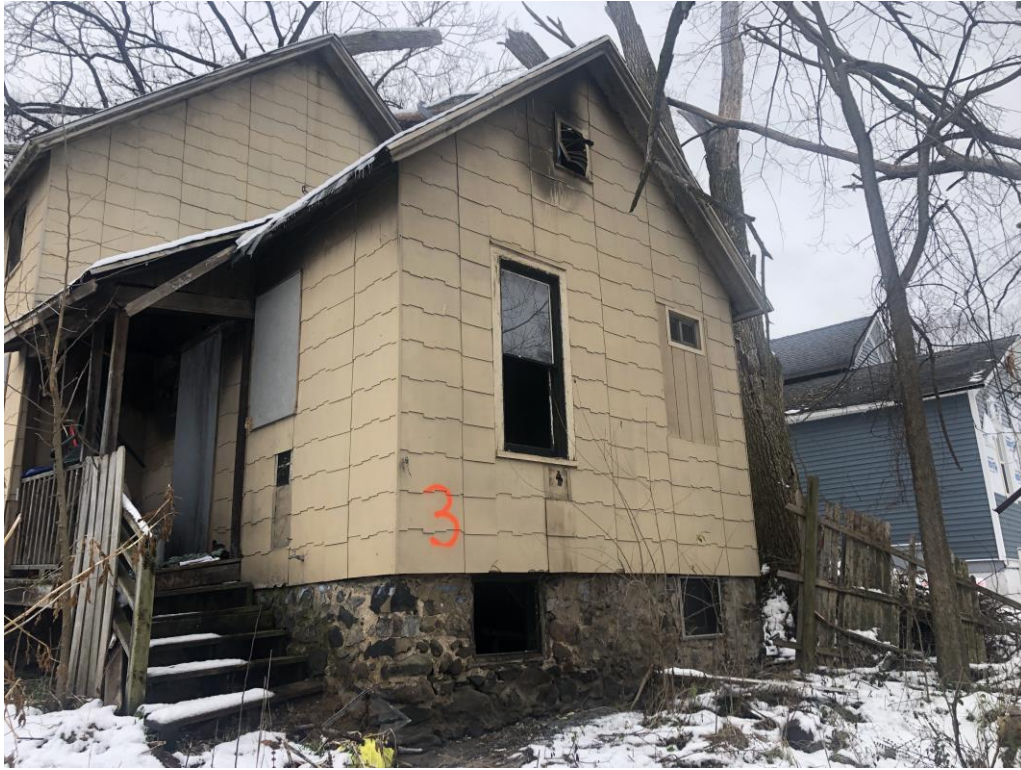
View of the rear of the house (EA-3)

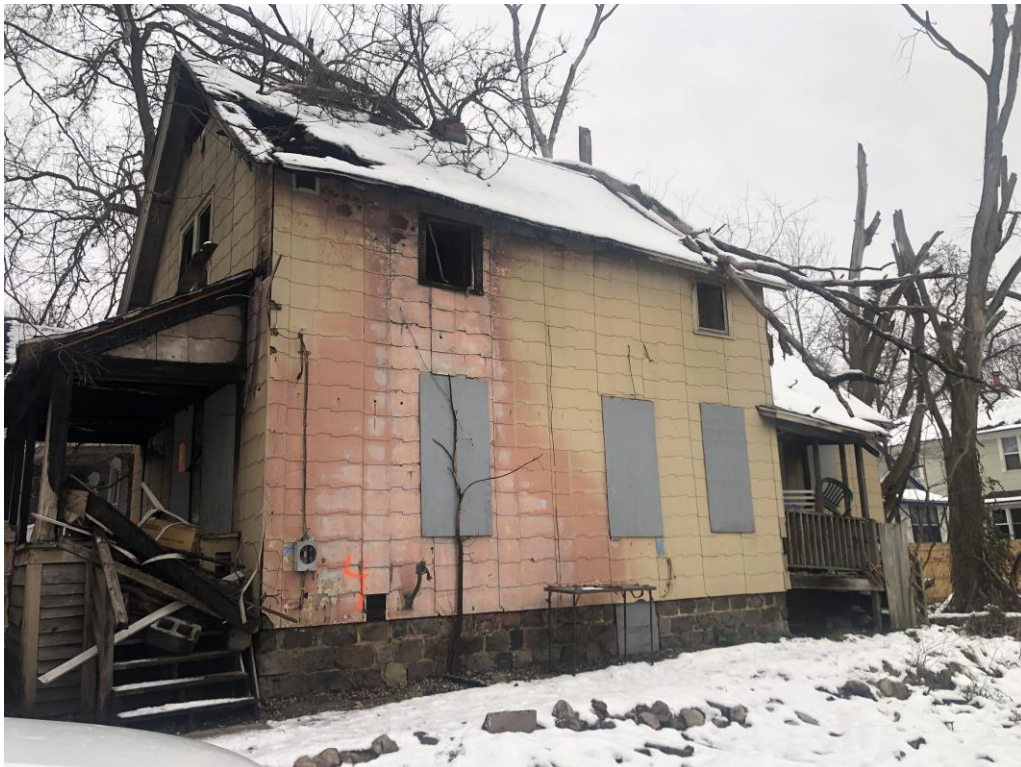
View of the right side of the house (EA-4)

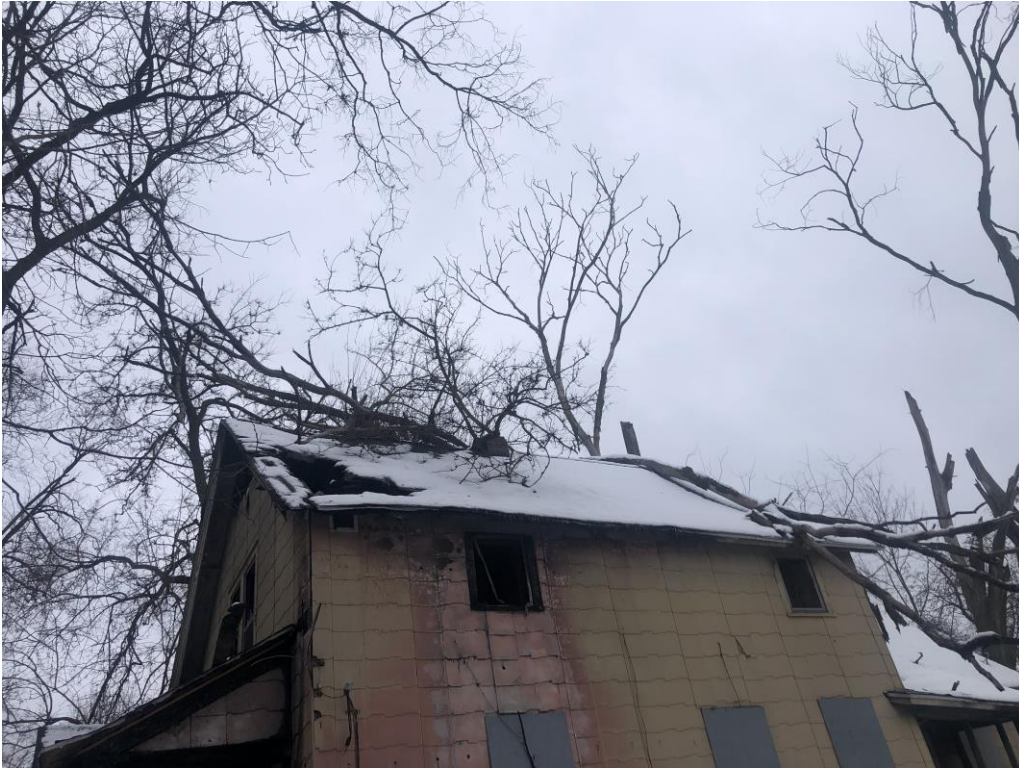
Roofing materials that were not tested during this inspection should be assumed to be Category I asbestos-containing roofing materials.

View of the roof (EA-5)

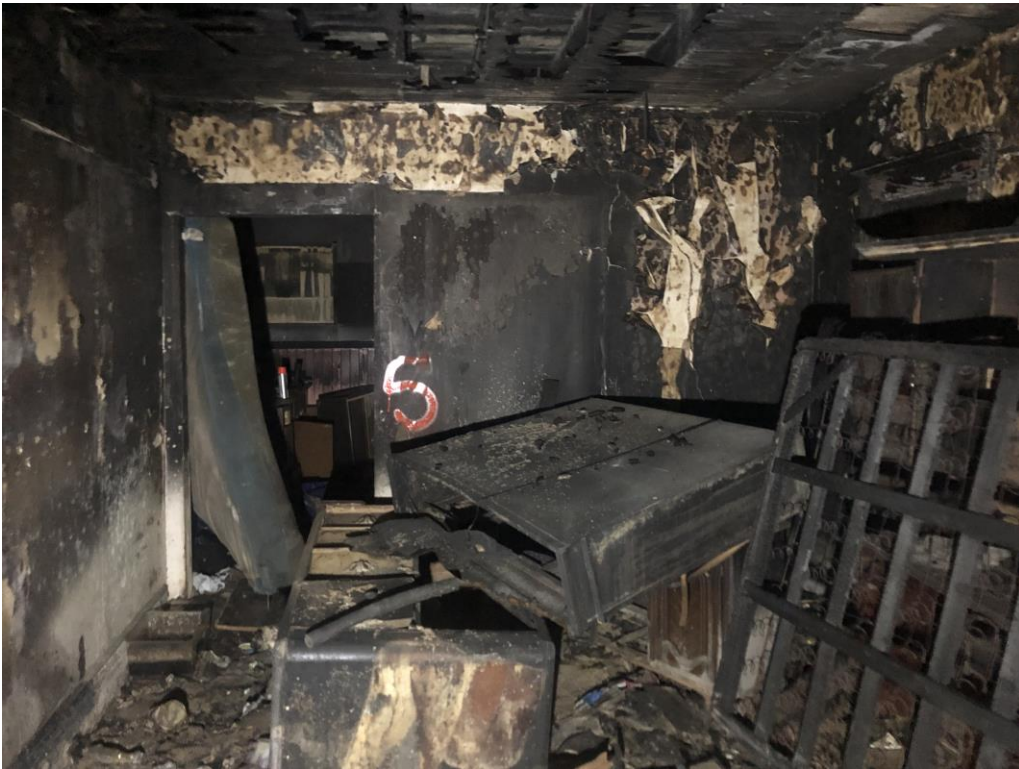
View of the house interior (FS-1)

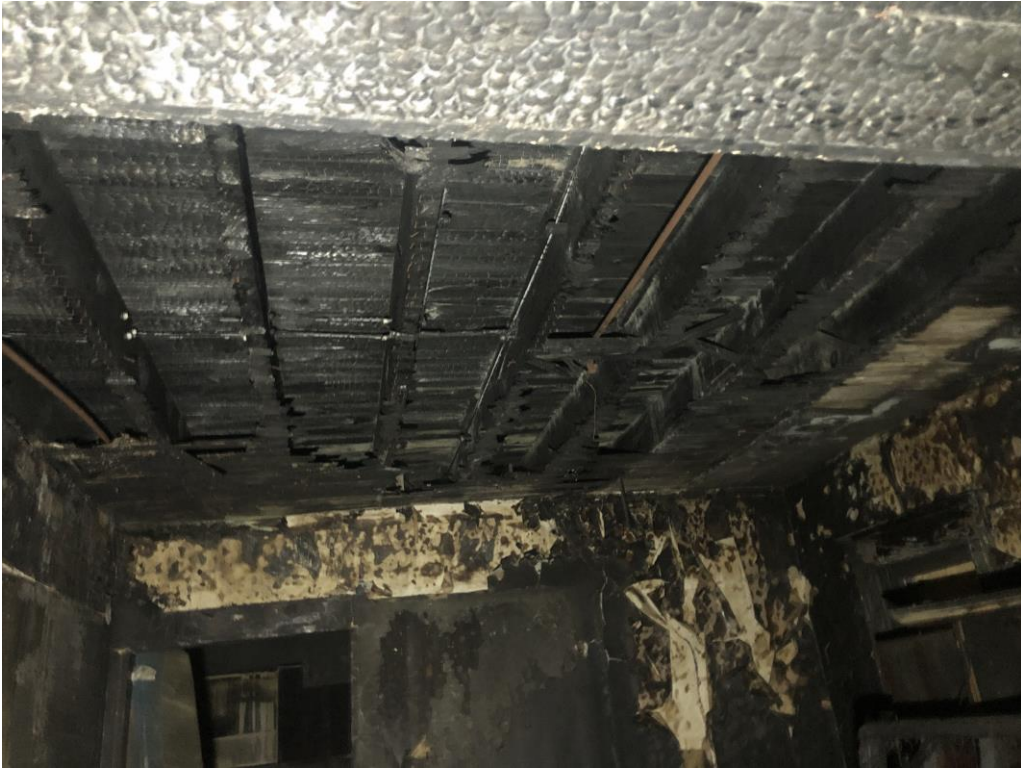
View of the fire damaged 2nd floor joists

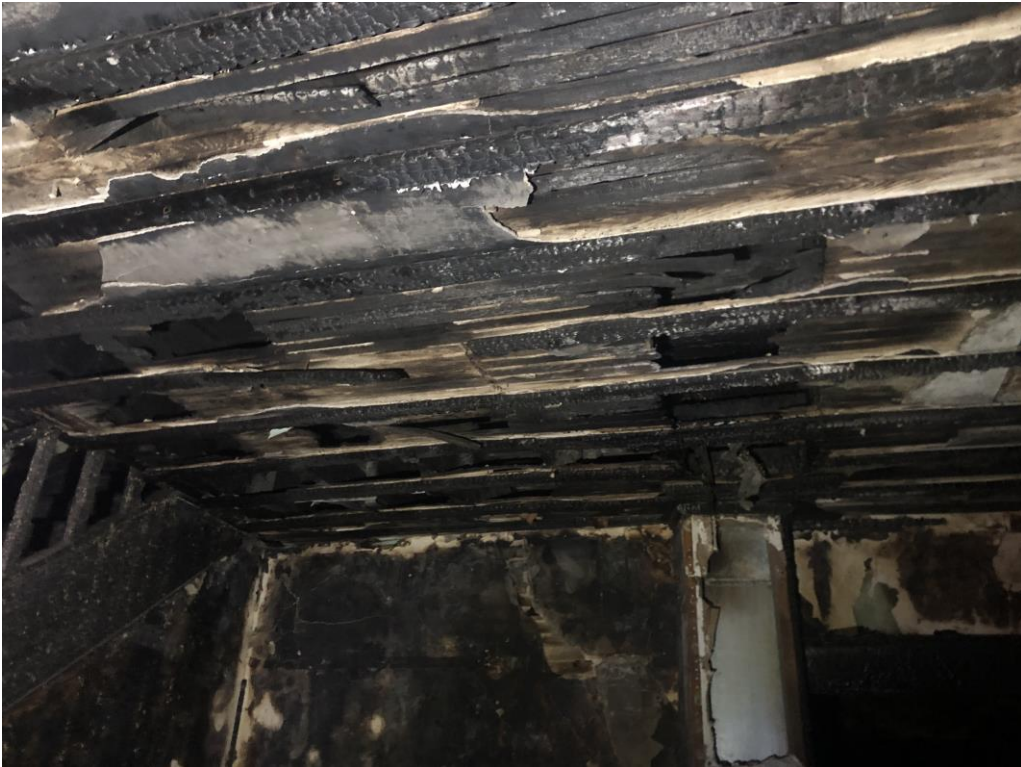
View of the fire damaged 2nd floor joists continued
