Client Name:	City of Kalamazoo
Project Name:	Commercial Building Asbestos Survey
Project Number:	188BS23418
Project Site Address (Subject Property):	1011 Cobb Street, Kalamazoo, MI 49700
Date of Site Visit:	May 24, 2023
Asbestos Inspection Performed by:	Corey Pruitt (A57116)
Asbestos Inspector's Signature:

ASBESTOS-CONTAINING MATERIAL SURVEY  
VACANT RESIDENTIAL PROPERTY  
1011 COBB STREET  
KALAMAZOO, MI 49007

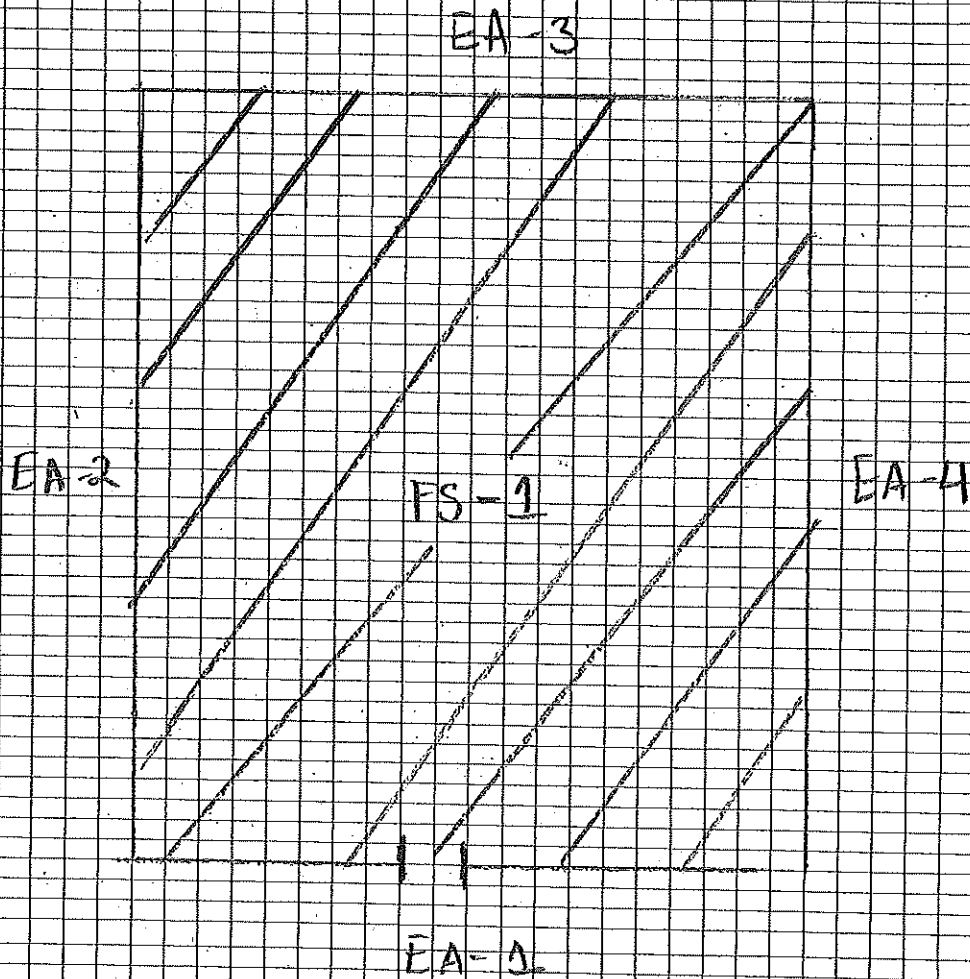
EA5  
ROOF

HA/ID#	MATERIAL	LOCATION	RESULT
1-RM-A,B,C	Roofing Material	EA 5	ND
2-VP-A,B,C	Vapor Paper (Under Roofing)	EA 5	ND
3-WG-A,B,C	Window Glaze	EA 5	ND
