Client Name:	City of Kalamazoo
Project Name:	Commercial Building Asbestos Survey
Project Number:	188BS23419
Project Site Address (Subject Property):	1423 N Edwards, Kalamazoo, MI 49700
Date of Site Visit:	May 24, 2023
Asbestos Inspection Performed by:	Corey Pruitt (A57116)
Asbestos Inspector's Signature:

On the date indicated above, State of Michigan Asbestos Inspector, Corey Pruitt (A57116) from Atlas Technical Consultants, conducted a pre-demolition asbestos and other regulated materials inspection of the subject unoccupied commercial property.

ASBESTOS-CONTAINING MATERIAL SURVEY
VACANT RESIDENTIAL PROPERTY
1423 N EDWARDS ST.
KALAMAZOO, MI 49007

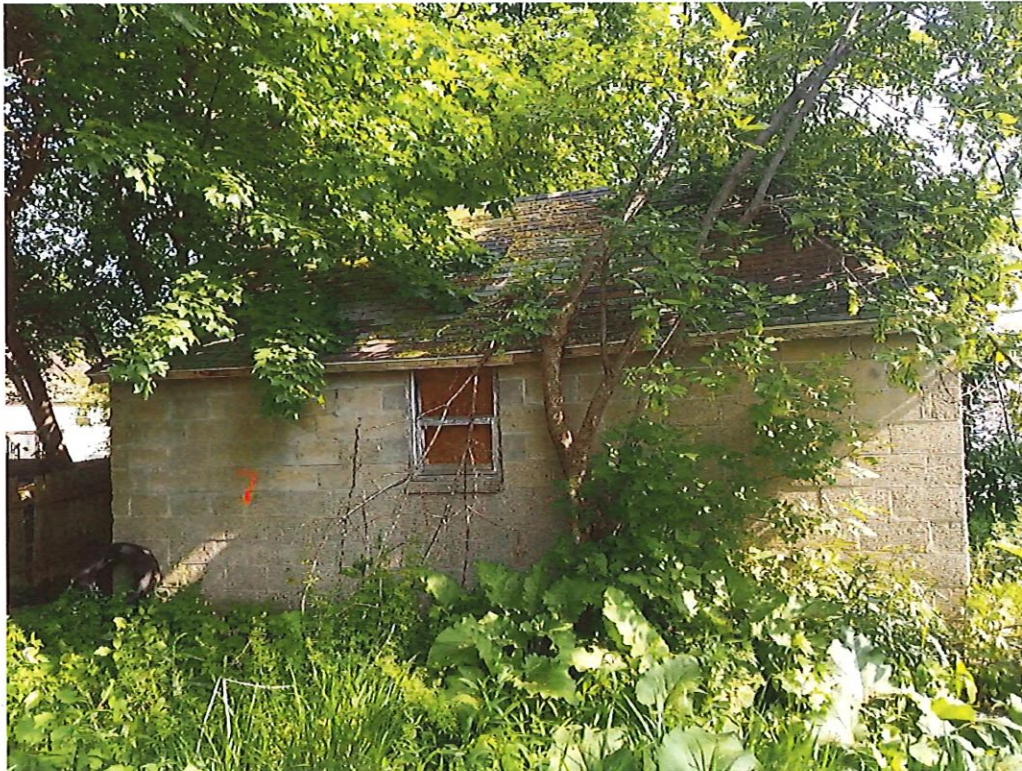
View of EA-7

ID#	MATERIAL	LOCATION	QUANTITY	RESULT	NESHAP CATEGORY
6-WG-A,B,C	Window Glaze	EA 7,8,9	3 WINDOWS	PLM 3% Chrysotile	Cat II
15-PI-A,B,C	Pipe Insulation	FS 1	10 SF	PLM 40% Chrysotile	RACM

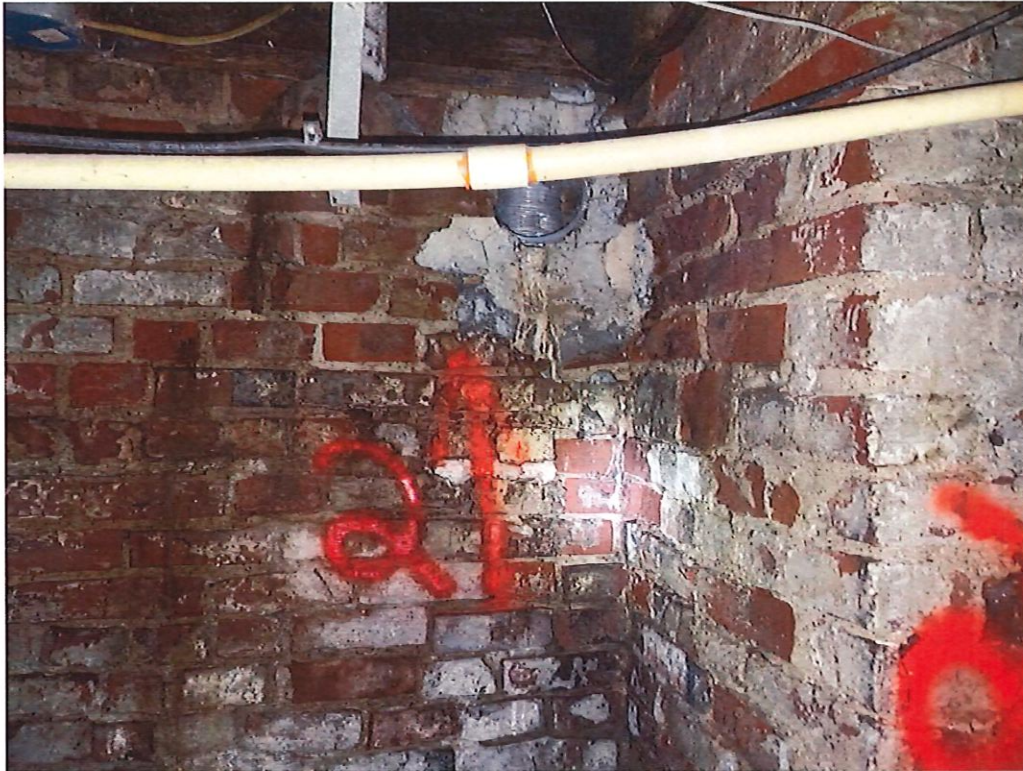
View of FS-2

MATERIAL	LOCATION	APPROXIMATE QUANTITY
CFC's Air Conditioners/Refrigerators/Freezers/Dehumidifiers	FS-2,5,9,11	4
CRTs/TV Screens/Monitors/Electronics	FS-12	2
Misc. Items (Glue, Solvents, Cleaners, etc.)	FS-1, FS-12	140
Natural Gas Regulator	FS-1	1
