PROJECT NAME: Demolition of 1 House

BID REFERENCE #: 91240-013.0

ASBESTOS-CONTAINING MATERIAL SURVEY
VACANT RESIDENTIAL PROPERTY

120 BURR OAK STREET
KALAMAZOO, MI 49001

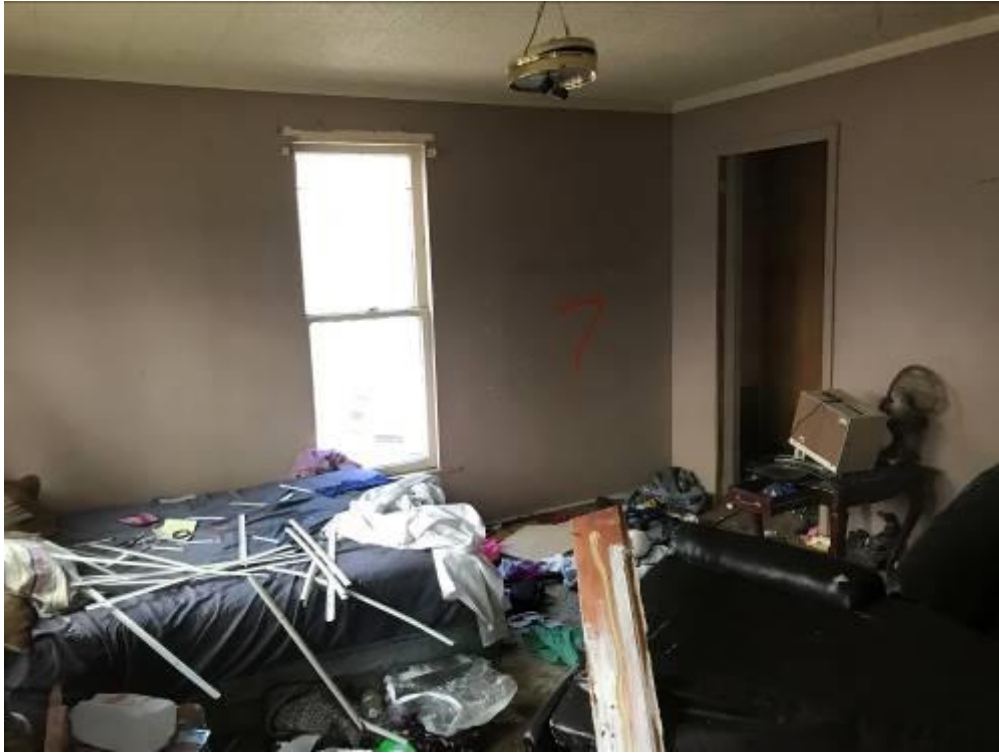
View of bedroom #1 (FS-7)

HA/ID#	MATERIAL	LOCATION	RESULT
13-FT-A,B,C	Floor tile - 9'x9' white	FS-7	5% Chrysotile (floor tile) ND (mastic)
14-FT-A,B,C	Floor tile - 12"x12" white	FS-9	ND
15-FT-A,B,C	Floor tile - 9"x9" – black	FS-10	4% Chrysotile (floor tile) ND (mastic & tar paper)
16-MLF-A,B,C	Multi-Layer Floor	FS-11	7% Chrysotile
17-FT-A,B,C	Floor tile - 9"x9" - cream with green streaks	FS-16,21	ND – All Layers
18-FT-A,B,C	Floor tile - 9"x9" - cream with brown streaks	FS-18	ND – All Layers
19-CP-A,B,C	Ceiling panel - 2'x4' pinhole and fissure	FS-6	ND
20-CT-A,B,C	Ceiling tile - 12"x12" rough texture	FS-7	ND
21-CT-A,B,C	Ceiling tile - 12"x12" smooth texture	FS-8	ND
22-CP-A,B,C	Ceiling panel - 2'x2' fissure texture	FS-8	ND
23-CP-A,B,C	Ceiling panel - 2'x4' popcorn texture	FS-20	ND
24-CT-A,B,C	Ceiling tile - 12"x12" swirl texture	FS-19	ND
25-CA-A,B,C	Construction adhesive - beige, on door	FS-7,8	ND

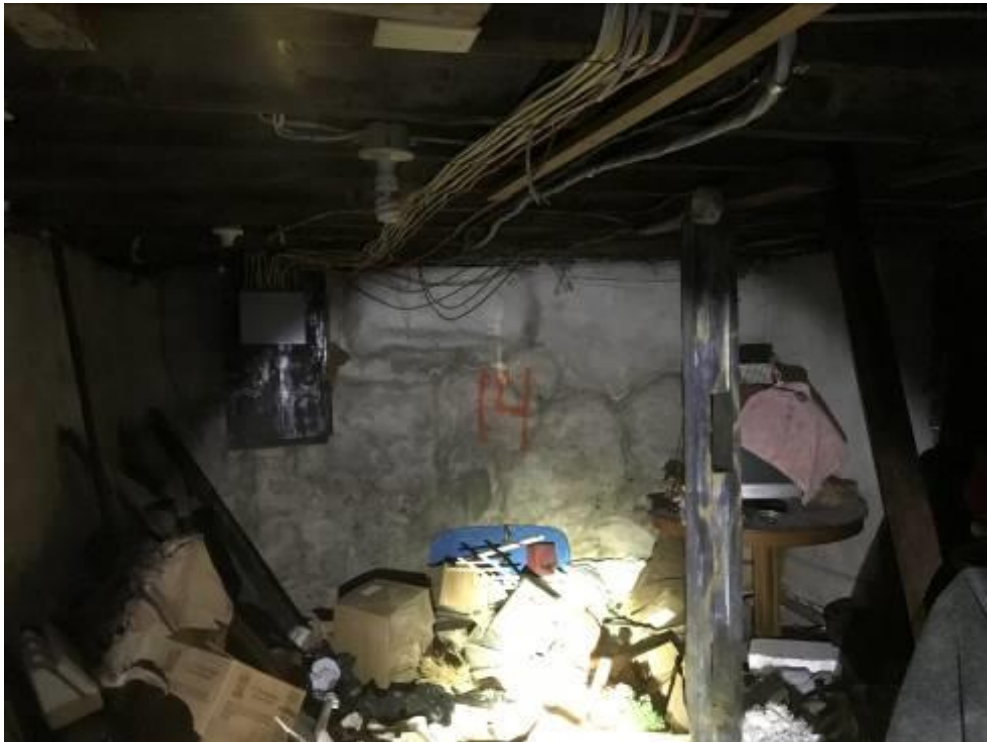
View of the basement (FS-14)

HA/ID#	MATERIAL	LOCATION	RESULT
26-BM-A,B,C	Brick and mortar - chimney stack	FS-15	ND
27-BM-A,B,C	Brick and mortar - basement rock and mortar foundation	FS-14	ND
28-CC-A,B,C	Concrete chip - exterior concrete	EA-4	ND
29-CC-A,B,C	Concrete chip - basement floor and concrete foundation walls	FS-14	ND
30-CM-A,B,C	Carpet mastic - brown	FS-6,7,10	ND
31-CB-A,B,C	Cove base and adhesive - 4" tan	FS-18	ND – All Layers
32-MLF-A,B,C	Multi layered floor	FS-19	ND – All Layers
33-TPL-A,B,C	Textured plaster - rough texture, located under drywall layer	FS-8	ND
34-CC-A,B,C	Stack Cement	FS-15	ND
